Access Compliance Report

Public Rights-of-Way

(Curb Ramps)

Intersection ID: 9360	Main Street: BOONE_ST	Cross Street: OAKLAWN_AV	Location: NW
ADA ID: BF314B630BEB	Ramp Type: Perp	Initial Pass/Fail: Fail	Overall Compliance: No
		Severity Score: 25

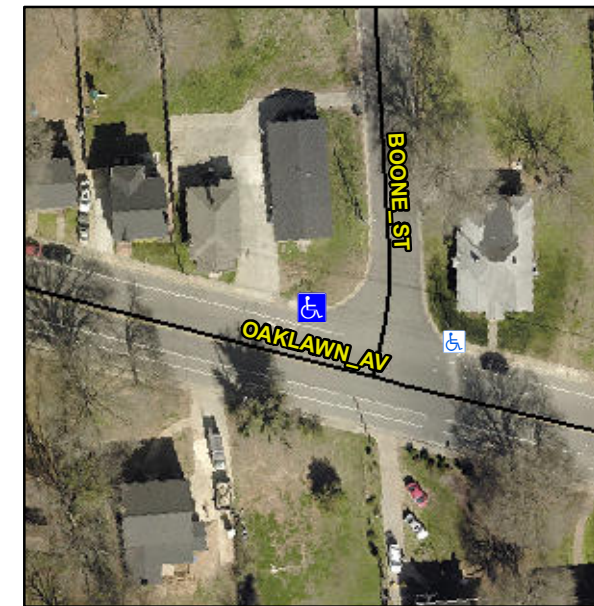
Not Found, R304.2.2, R304.5.3

Compliance	Description	Data	Compliance	Description	Data
N/A	Ramp Length (in)	55.0	No	Ramp Slope (%)	9.5
Yes	Ramp Width (in)	48.0	No	Ramp XSlope (%)	5.4
N/A	Flare Type LT	N/A	N/A	Flare Type RT	N/A
N/A	Flare Slope LT (%)	N/A	N/A	Flare Slope RT (%)	N/A
N/A	Flare Traversable LT?	N/A	N/A	Flare Traversable RT?	N/A
N/A	Landing Length (in)	N/A	N/A	DWS Provided?	N/A
N/A	Landing Width (in)	N/A	N/A	DWS Contrast?	N/A
N/A	Landing Slope (%)	N/A	N/A	DWS Length (in)	N/A
N/A	Landing X Slope (%)	N/A	N/A	DWS Full Width?	N/A
N/A	Landing Curb? (Y/N)	N/A	N/A	DWS Offset (in)	N/A
N/A	Shared Landing?	N/A			
N/A	Gutter Ponding?	N/A	N/A	Gutter Slope (%)	N/A
N/A	Gutter Lip Ht (in)	N/A	N/A	Gutter X Slope (%)	N/A
N/A	Painted X Walk1?	No	N/A	Painted X Walk2?	N/A
	X Walk 1 Direction	To SE		X Walk 2 Direction	N/A
N/A	X Walk 1 Width (in)	N/A	N/A	X Walk 2 Width (in)	N/A
	X Walk 1 Slope (%)	2.6		X Walk 2 Slope (%)	N/A
	X Walk 1 X Slope (%)	5.0		X Walk 2 X Slope (%)	N/A

Remove & Replace Entire Ramp.
