Access Compliance Report

Public Rights-of-Way

(Curb Ramps)

Intersection ID: 11894	Main Street: N_BREVARD_ST	Cross Street: E_12TH_ST	Location: W
ADA ID: BF33998A79B7	Ramp Type: Directional1	Initial Pass/Fail: Pass	Overall Compliance: No
Severity Score: 0			
Codes/Mitigation Info/Possible Solution		Field Measurements/Component Compliance

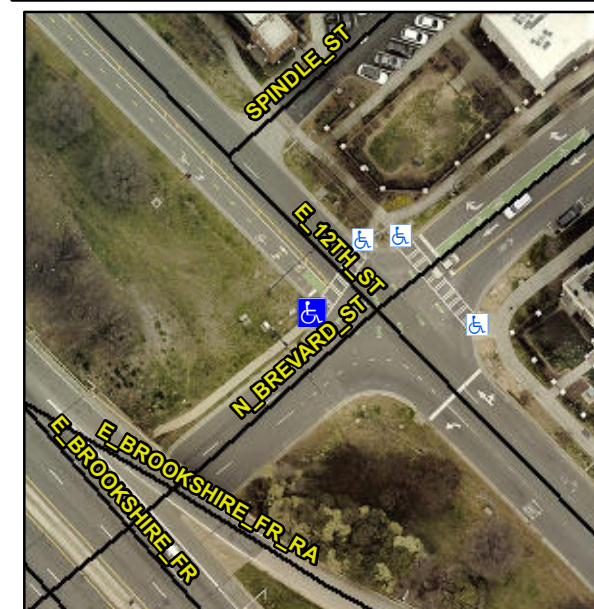
Compliance	Description	Data	Compliance	Description	Data
N/A	Ramp Length (in)	95.0	Yes	Grade Break?	Yes
Yes	Ramp Width (in)	59.0	Yes	Grade Break Slope (%)	1.2
Yes	Ramp Slope (%)	2.1	Yes	Grade Break XSlope (%)	0.5
Yes	Ramp XSlope (%)	1.1			
Yes	Flare Type LT	N/A	Yes	Flare Type RT	N/A
N/A	Flare Slope LT (%)	N/A	N/A	Flare Slope RT (%)	N/A
N/A	Flare Traversable LT?	No	N/A	Flare Traversable RT?	No
Yes	Landing Length (in)	62.0	Yes	DWS Provided?	Yes
Yes	Landing Width (in)	59.0	Yes	DWS Contrast?	Yes
No	Landing Slope (%)	5.8	Yes	DWS Length (in)	24.0
No	Landing X Slope (%)	2.5	Yes	DWS Full Width?	Yes
N/A	Landing Curb? (Y/N)	No	No	DWS Offset LT (in)	2.5
N/A	Shared Landing?	Yes	Yes	DWS Offset RT (in)	29.0
No	Gutter Ponding?	Yes	Yes	Gutter Slope (%)	1.6
Yes	Gutter Lip Ht (in)	0.0	Yes	Gutter X Slope (%)	1.0
N/A	Painted X Walk1?	Yes		Road Slope (%)	3.0
	X Walk 1 Direction	To NE		Road X Slope (%)	1.2
	X Walk 1 Width (in)	85.0		Clear Space?	Yes

X Walk 1 Slope (%)	3.0	N/A	Clear Space to XWalk (in)	N/A
	X Walk 1 X Slope (%)	1.2	Yes	Storm Grate/Utility Hazard?	No
Yes	Ramp inside XWalk1?	Yes		Storm Grate/Utility Type	
Yes	Any Obstructions?	No			N/A
	Obstruction Type		Yes	Surface Condition? (G/P)	Good
			N/A	Curb Slope (%)	12.3

Possible Solutions:

Remove & Replace Entire Ramp.
