Access Compliance Report

Public Rights-of-Way

(Curb Ramps)

Intersection ID: 20905	Main Street: SARDIS_GREEN_CT	Cross Street: SARDIS_LN	Location: NW
ADA ID: BF33CCEDD1B7	Ramp Type: Directional1	Initial Pass/Fail: Fail	Overall Compliance: No
Severity Score: 12.5			
Codes/Mitigation Info/Possible Solution		Field Measurements/Component Compliance

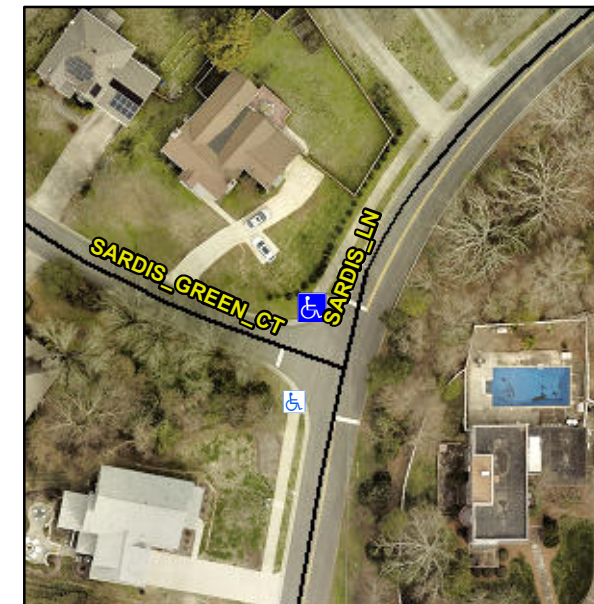
Compliance	Description	Data	Compliance	Description	Data
N/A	Ramp Length (in)	112.0	N/A	Grade Break?	N/A
Yes	Ramp Width (in)	66.0	N/A	Grade Break Slope (%)	0.0
No	Ramp Slope (%)	9.0	N/A	Grade Break XSlope (%)	0.0
Yes	Ramp XSlope (%)	1.9			
N/A	Flare Type LT	N/A	N/A	Flare Type RT	N/A
N/A	Flare Slope LT (%)	N/A	N/A	Flare Slope RT (%)	0.0
N/A	Flare Traversable LT?	N/A	N/A	Flare Traversable RT?	N/A
N/A	Landing Length (in)	0.0	N/A	DWS Provided?	N/A
N/A	Landing Width (in)	0.0	N/A	DWS Contrast?	N/A
N/A	Landing Slope (%)	0.0	N/A	DWS Length (in)	N/A
N/A	Landing X Slope (%)	0.0	N/A	DWS Full Width?	N/A
N/A	Landing Curb? (Y/N)	N/A	N/A	DWS Offset LT (in)	N/A
N/A	Shared Landing?	N/A	N/A	DWS Offset RT (in)	N/A
N/A	Gutter Ponding?	0.0	N/A	Gutter Slope (%)	N/A
N/A	Gutter Lip Ht (in)	0.0	N/A	Gutter X Slope (%)	N/A
N/A	Painted X Walk1?	No		Road Slope (%)	2.6
	X Walk 1 Direction	To SE		Road X Slope (%)	3.9
	X Walk 1 Width (in)	N/A		Clear Space?	N/A

X Walk 1 Slope (%)	2.6	N/A	Clear Space to XWalk (in)	N/A
	X Walk 1 X Slope (%)	3.9	N/A	Storm Grate/Utility Hazard?	N/A
N/A	Ramp inside XWalk1?	N/A		Storm Grate/Utility Type	
N/A	Any Obstructions?	N/A			N/A
	Obstruction Type		Yes	Surface Condition? (G/P)	Good
			N/A	Curb Slope (%)	2.4

Possible Solutions:

Remove & Replace Entire Ramp.

R304.2.2

\$ 1600.00
