# Access Compliance Report

## Public Rights-of-Way

### (Curb Ramps)

Intersection ID: 12646	Main Street: LEVINE AVENUE OF THE ARTS	Cross Street: S TRYON ST	Location: W
ADA ID: BF37FB3DB36E	Ramp Type: Perp	Initial Pass/Fail: Fail	Overall Compliance: No
Codes/Mitigation Info/Possible Solution		Field Measurements/Component Compliance	
Severity Score: 13.75

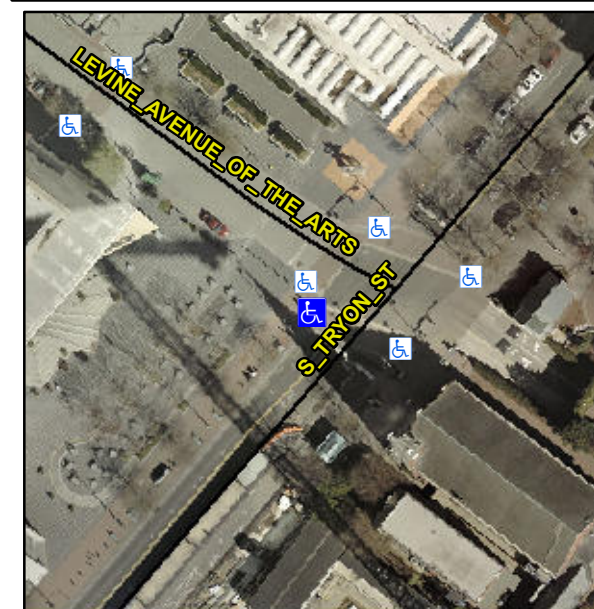
Compliance	Description	Data	Compliance	Description	Data
N/A	Ramp Length (in)	57.0	No	Ramp Slope (%)	11.1
Yes	Ramp Width (in)	52.0	No	Ramp XSlope (%)	4.3
N/A	Flare Type LT	N/A	N/A	Flare Type RT	N/A
N/A	Flare Slope LT (%)	N/A	N/A	Flare Slope RT (%)	N/A
N/A	Flare Traversable LT?	N/A	N/A	Flare Traversable RT?	N/A
N/A	Landing Length (in)	N/A	N/A	DWS Provided?	N/A
N/A	Landing Width (in)	N/A	N/A	DWS Contrast?	N/A
N/A	Landing Slope (%)	N/A	N/A	DWS Length (in)	N/A
N/A	Landing X Slope (%)	N/A	N/A	DWS Full Width?	N/A
N/A	Landing Curb? (Y/N)	N/A	N/A	DWS Offset (in)	N/A
N/A	Shared Landing?	N/A			
N/A	Gutter Ponding?	N/A	N/A	Gutter Slope (%)	N/A
N/A	Gutter Lip Ht (in)	N/A	N/A	Gutter X Slope (%)	N/A
N/A	Painted X Walk1?	Yes	N/A	Painted X Walk2?	N/A
	X Walk 1 Direction	To SE		X Walk 2 Direction	N/A
N/A	X Walk 1 Width (in)	144.0	N/A	X Walk 2 Width (in)	N/A
	X Walk 1 Slope (%)	0.8		X Walk 2 Slope (%)	N/A
	X Walk 1 X Slope (%)	2.8		X Walk 2 X Slope (%)	N/A

N/A	Ramp inside XWalk1?	Yes	N/A	Ramp inside XWalk2?	N/A
	Road Slope (%)	N/A	N/A	Clear Space?	N/A
	Road X Slope (%)	N/A	N/A	Clear Space to XWalk (in)	N/A
N/A	Any Obstructions?	N/A	N/A	Storm Grate/Utility Hazard?	N/A
	Obstruction Type			Storm Grate/Utility Type	
		N/A			N/A
			Yes	Surface Condition? (G/P)	Good

**Remove & Replace Entire Ramp.**

**Not Found, R304.2.2, R304.5.3**
