# Access Compliance Report

## Public Rights-of-Way

### (Curb Ramps)

| Intersection ID: 20419 | Main Street: PARK_SOUTH_DR | Cross Street: ROYAL_CREST_DR | Location: NW |

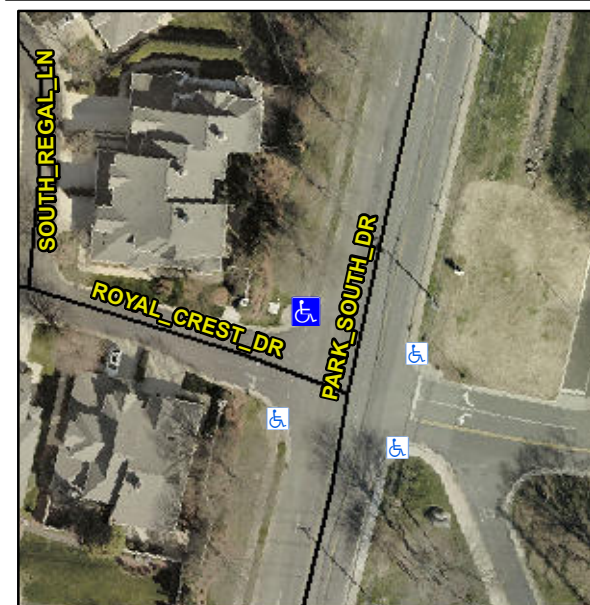
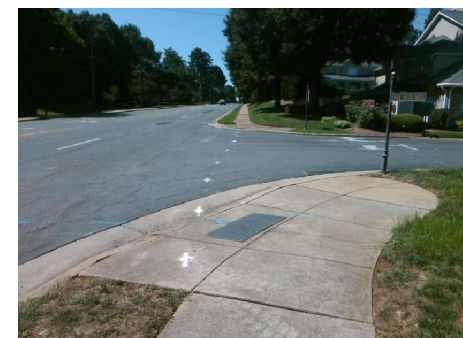
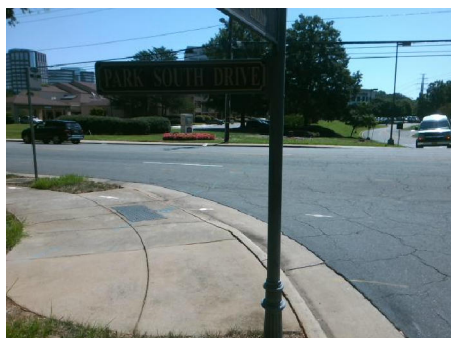
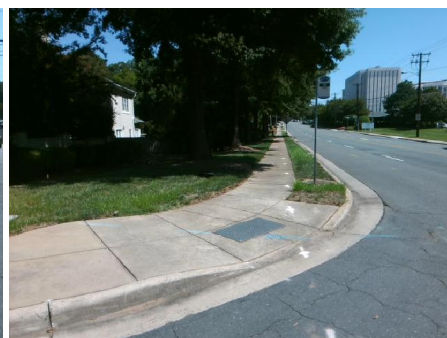
| ADA ID: BF38373DED06 | Ramp Type: PerpDiag | Initial Pass/Fail: Pass | Overall Compliance: No |
| Severity Score: 12.75 | | | |

**Not Found, R304.5.3, R304.2.1, R304.2.2-Perp, R304.3.2-Para, R304.2.3, R305.1.4, R305.2, R304.5.4**

| Compliance | Description | Data | Compliance | Description | Data |
|---|---|---|---|---|---|
| Yes | Ramp Width (in) | 61.0 | No | Ramp XSlope (%) | 2.4 |
| No | Landing Length (in) | 36.0 | Yes | DWS Provided? | Yes |
| No | Landing Slope (%) | 3.1 | Yes | DWS Length (in) | 24.0 |
| Yes | Landing X Slope (%) | 1.0 | No | DWS Full Width? | No |
| N/A | Landing Curb? (Y/N) | No | No | DWS Offset (in) | 20.5 |
| Yes | Gutter Ponding? | No | No | Gutter Slope (%) | 10.4 |

**Remove & Replace Curb Ramp With Two New Directional Ramps or Equivalent. Remove & Replace Gutter.**

Total Cost: \$ **3950.00**
