Access Compliance Report

Public Rights-of-Way

(Curb Ramps)

Intersection ID: 18158	Main Street: CHARING_PL	Cross Street: REDCOAT_DR	Location: S
ADA ID: BF3D476BDD93	Ramp Type: BlendTrans2	Initial Pass/Fail: Fail	Overall Compliance: No
		Severity Score: 10

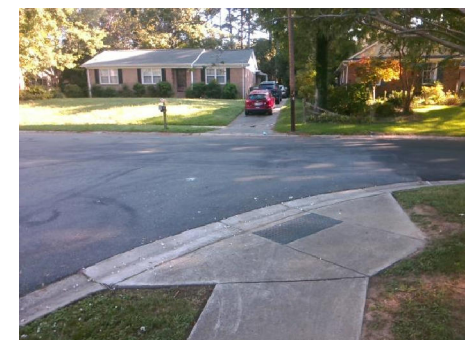
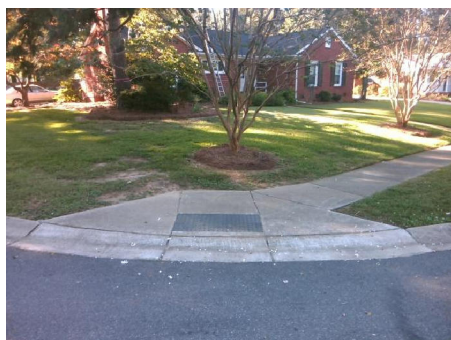
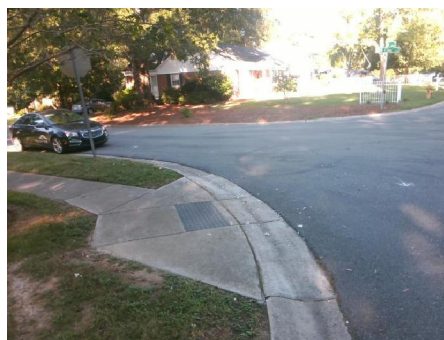
Compliance	Description	Data	Compliance	Description	Data
N/A	Ramp Length (in)	73.0	Yes	BlendTrans Slope (%)	4.3
No	Ramp Width (in)	47.0	No	BlendTrans XSlope (%)	3.4
N/A	Flare Type LT	N/A	N/A	Flare Type RT	N/A
N/A	Flare Slope LT (%)	N/A	N/A	Flare Slope RT (%)	N/A
N/A	Flare Traversable LT?	N/A	N/A	Flare Traversable RT?	N/A
N/A	Landing Length (in)	N/A	N/A	DWS Provided?	N/A
N/A	Landing Width (in)	N/A	N/A	DWS Contrast?	N/A
N/A	Landing Slope (%)	N/A	N/A	DWS Length (in)	N/A
N/A	Landing X Slope (%)	N/A	N/A	DWS Full Width?	N/A
N/A	Landing Curb? (Y/N)	N/A	N/A	DWS Offset (in)	N/A
N/A	Shared Landing?	N/A			
N/A	Gutter Ponding?	N/A	N/A	Gutter Slope (%)	N/A
N/A	Gutter Lip Ht (in)	N/A	N/A	Gutter X Slope (%)	N/A
N/A	Painted X Walk1?	No	N/A	Painted X Walk2?	No
	X Walk 1 Direction	To NE		X Walk 2 Direction	To NW
	X Walk 1 Width (in)	N/A		X Walk 2 Width (in)	N/A
	X Walk 1 Slope (%)	4.7		X Walk 2 Slope (%)	3.2
	X Walk 1 X Slope (%)	0.3		X Walk 2 X Slope (%)	3.7

N/A	Ramp inside XWalk1?	N/A	N/A	Ramp inside XWalk2?	N/A
	Road Slope (%)	2.8		Clear Space?	N/A
	Road X Slope (%)	6.4	N/A	Clear Space to XWalk (in)	N/A
N/A	Any Obstructions?	N/A	N/A	Storm Grate/Utility Hazard?	N/A
	Obstruction Type			Storm Grate/Utility Type	
		N/A			N/A
			Yes	Surface Condition? (G/P)	Good
			N/A	Curb Slope (%)	4.4

Remove & Replace Curb Ramp With Two New Directional Ramps or Equivalent.

R304.5.1, R304.5.3
