# Access Compliance Report

## Public Rights-of-Way

### (Curb Ramps)

| Intersection ID: 47970 | Main Street: KYRENE_RD | Cross Street: HAWK_SHADOW_LN | Location: NW |

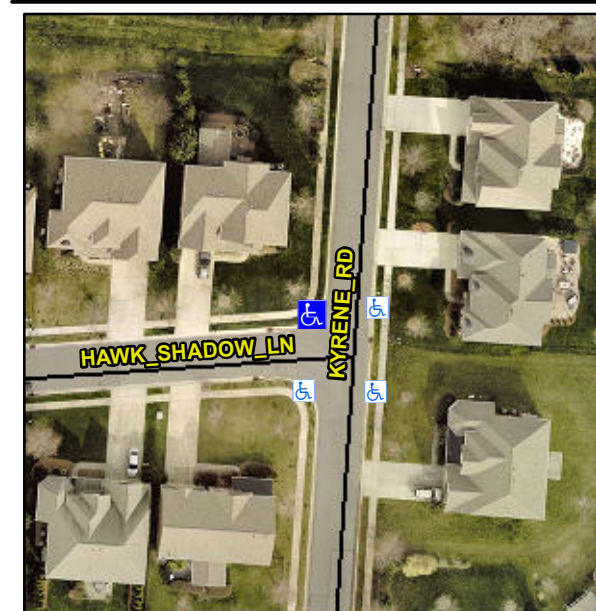
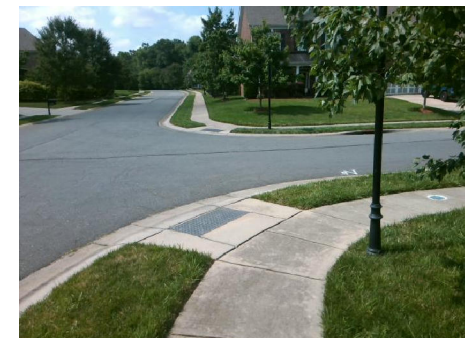
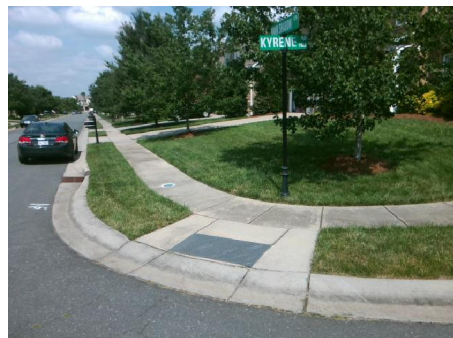
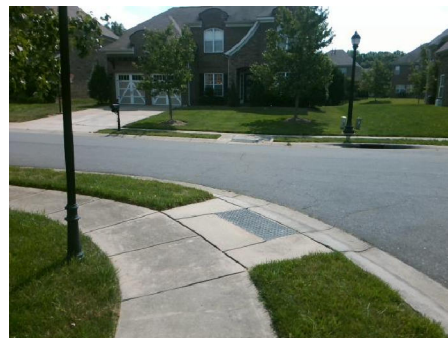
**CURB GAP 1.0**

**Not Found, R304.5.3, R304.2.1, R304.5.4**

| Compliance | Description | Data | Compliance | Description | Data |
|---|---|---|---|---|---|
| Yes | Ramp Width (in) | 48.0 | No | BlendTrans XSlope (%) | 2.8 |
| No | Landing Length (in) | 44.0 | Yes | DWS Provided? | Yes |
| No | Landing X Slope (%) | 3.0 | Yes | DWS Full Width? | Yes |
| Yes | Gutter Ponding? | No | No | Gutter Slope (%) | 9.0 |
| Yes | Gutter Lip Ht (in) | 0.0 | No | Gutter X Slope (%) | 3.5 |
| | | | No | Curb Slope (%) | 9.6 |

**Remove & Replace Curb Ramp With Two New Directional Ramps or Equivalent. Remove & Replace Gutter.**
