# Access Compliance Report

## Public Rights-of-Way

### (Curb Ramps)

Intersection ID: 7087	Main Street: COTTAGEVILLE_LN	Cross Street: MELYNDA_RD	Location:	S
ADA ID: BF3E4D7270FE	Ramp Type: Perp	Initial Pass/Fail: Fail	Overall Compliance: No	Severity Score: 22.5
Codes/Mitigation Info/Possible Solution		Field Measurements/Component Compliance

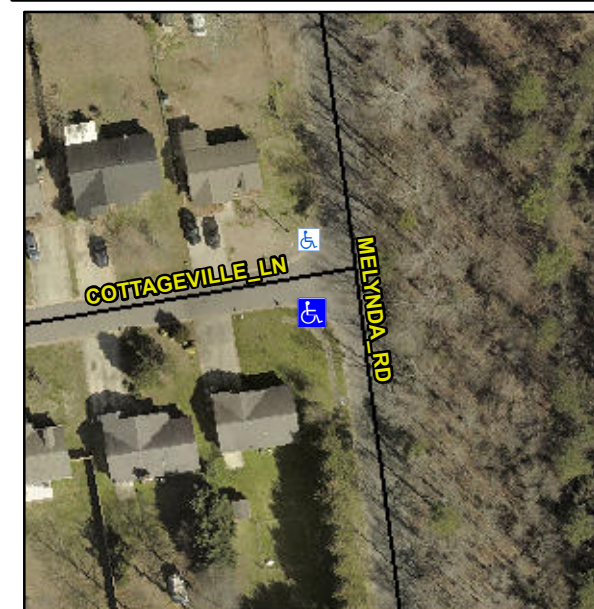
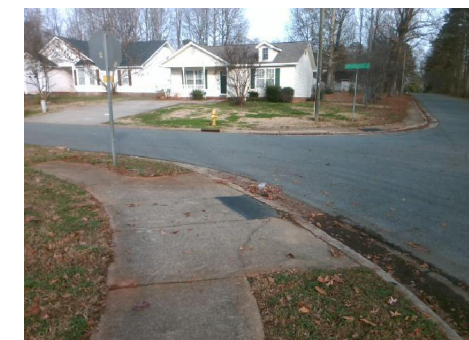
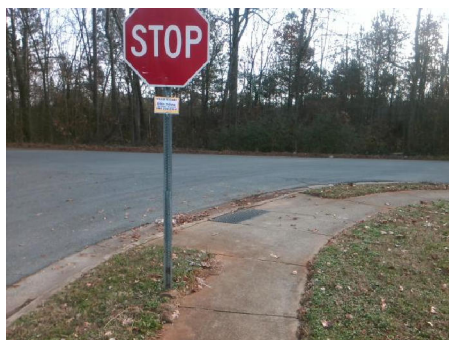
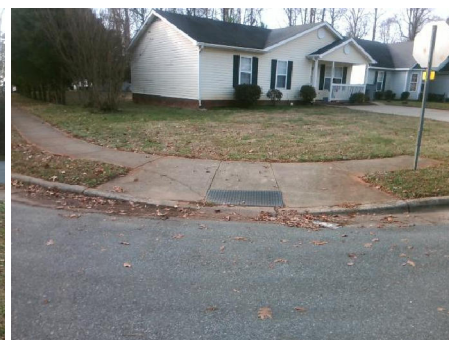
**Not Found, R304.5.1, R304.2.2, R304.5.3**

Compliance	Description	Data	Compliance	Description	Data
N/A	Ramp Length (in)	97.0	No	Ramp Slope (%)	9.1
No	Ramp Width (in)	41.0	No	Ramp XSlope (%)	2.6
N/A	Flare Type LT	N/A	N/A	Flare Type RT	N/A
N/A	Flare Slope LT (%)	N/A	N/A	Flare Slope RT (%)	N/A
N/A	Flare Traversable LT?	N/A	N/A	Flare Traversable RT?	N/A
N/A	Landing Length (in)	N/A	N/A	DWS Provided?	N/A
N/A	Landing Width (in)	N/A	N/A	DWS Contrast?	N/A
N/A	Landing Slope (%)	N/A	N/A	DWS Length (in)	N/A
N/A	Landing X Slope (%)	N/A	N/A	DWS Full Width?	N/A
N/A	Landing Curb? (Y/N)	N/A	N/A	DWS Offset (in)	N/A
N/A	Shared Landing?	N/A			
N/A	Gutter Ponding?	Yes	N/A	Gutter Slope (%)	N/A
N/A	Gutter Lip Ht (in)	N/A	N/A	Gutter X Slope (%)	N/A
N/A	Painted X Walk1?	No	N/A	Painted X Walk2?	N/A
	X Walk 1 Direction	To N		X Walk 2 Direction	N/A
N/A	X Walk 1 Width (in)	N/A	N/A	X Walk 2 Width (in)	N/A
	X Walk 1 Slope (%)	4.7		X Walk 2 Slope (%)	N/A
	X Walk 1 X Slope (%)	2.3		X Walk 2 X Slope (%)	N/A

N/A	Ramp inside XWalk1?	N/A	N/A	Ramp inside XWalk2?	N/A
	Road Slope (%)	N/A	N/A	Clear Space?	N/A
	Road X Slope (%)	N/A	N/A	Clear Space to XWalk (in)	N/A
N/A	Any Obstructions?	N/A	N/A	Storm Grate/Utility Hazard?	N/A
	Obstruction Type			Storm Grate/Utility Type	
		N/A			N/A
		Yes		Surface Condition? (G/P)	Good

**Remove & Replace Entire Ramp.**
