# Access Compliance Report

## Public Rights-of-Way

### (Curb Ramps)

| Intersection ID: 28442 | Main Street: IDLEWILD_RD | Cross Street: NARAYAN_ST | Location: SE |

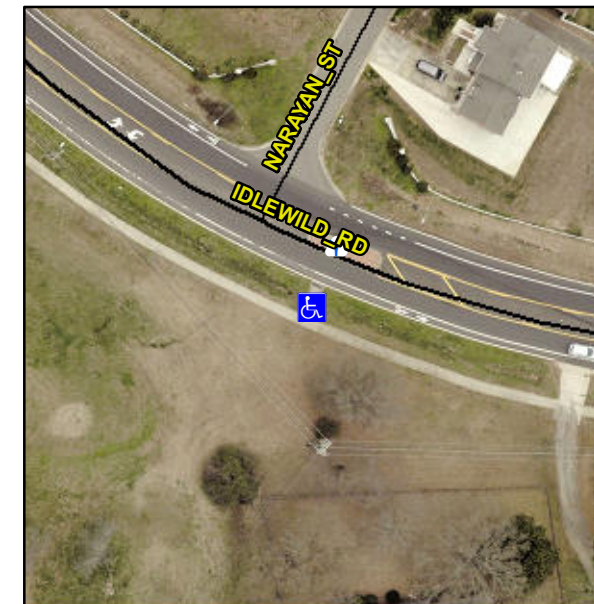
| ADA ID: BF446017692E | Ramp Type: BlendTrans1 | Initial Pass/Fail: Pass | Overall Compliance: No |

| Compliance | Description | Data | Compliance | Description | Data |
|---|---|---|---|---|---|
| N/A | Landing Curb? (Y/N) | No | No | DWS Offset (in) | 7.0 |
| Yes | Gutter Ponding? | No | No | Gutter Slope (%) | 6.0 |

Possible Solutions:

**Remove & Replace Detectable Warning System. Remove & Replace Gutter.**

**R305.2, R304.5.4**
