Access Compliance Report

Public Rights-of-Way

(Curb Ramps)

Intersection ID: 14305	Main Street: CLEVELAND_AV	Cross Street: E WORTHINGTON AV	Location: E
ADA ID: BF470AB93B8B	Ramp Type: Directional1	Initial Pass/Fail: Fail	Overall Compliance: No
Severity Score: 1.25			
Codes/Mitigation Info/Possible Solution		Field Measurements/Component Compliance

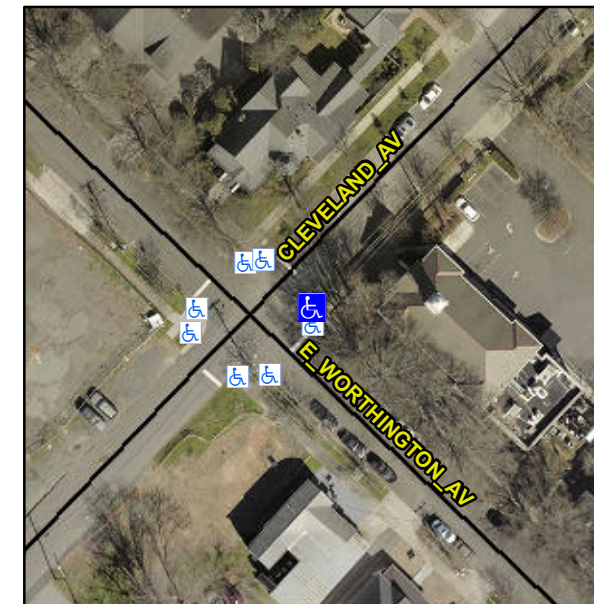
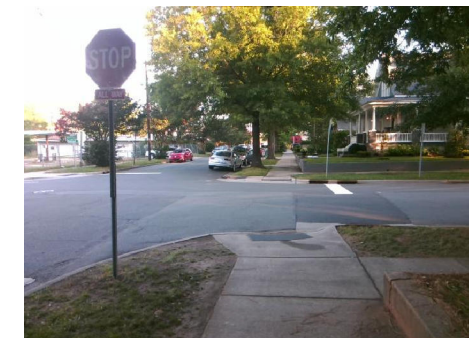
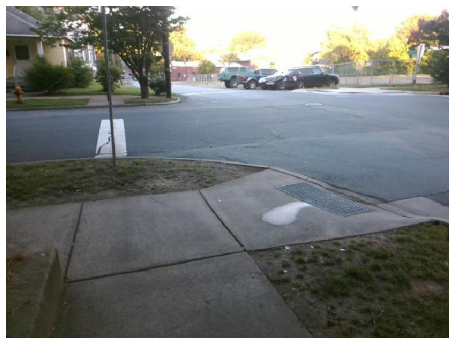
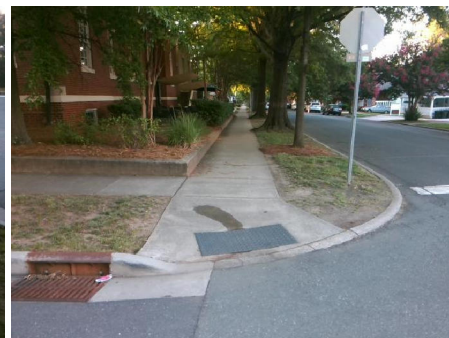
Compliance	Description	Data	Compliance	Description	Data
N/A	Ramp Length (in)	72.0	N/A	Grade Break?	N/A
Yes	Ramp Width (in)	60.0	N/A	Grade Break Slope (%)	0.0
Yes	Ramp Slope (%)	6.1	N/A	Grade Break XSlope (%)	0.0
No	Ramp XSlope (%)	4.4			
N/A	Flare Type LT	N/A	N/A	Flare Type RT	N/A
N/A	Flare Slope LT (%)	N/A	N/A	Flare Slope RT (%)	0.0
N/A	Flare Traversable LT?	N/A	N/A	Flare Traversable RT?	N/A
N/A	Landing Length (in)	0.0	N/A	DWS Provided?	N/A
N/A	Landing Width (in)	0.0	N/A	DWS Contrast?	N/A
N/A	Landing Slope (%)	0.0	N/A	DWS Length (in)	N/A
N/A	Landing X Slope (%)	0.0	N/A	DWS Full Width?	N/A
N/A	Landing Curb? (Y/N)	N/A	N/A	DWS Offset LT (in)	N/A
N/A	Shared Landing?	N/A	N/A	DWS Offset RT (in)	N/A
N/A	Gutter Ponding?	0.0	N/A	Gutter Slope (%)	N/A
N/A	Gutter Lip Ht (in)	0.0	N/A	Gutter X Slope (%)	N/A
N/A	Painted X Walk1?	No		Road Slope (%)	5.4
	X Walk 1 Direction	To NW		Road X Slope (%)	0.7
	X Walk 1 Width (in)	N/A		Clear Space?	N/A

X Walk 1 Slope (%)	5.4	N/A	Clear Space to XWalk (in)	N/A
	X Walk 1 X Slope (%)	0.7	N/A	Storm Grate/Utility Hazard?	N/A
N/A	Ramp inside XWalk1?	N/A		Storm Grate/Utility Type	
N/A	Any Obstructions?	N/A			N/A
	Obstruction Type		Yes	Surface Condition? (G/P)	Good
			N/A	Curb Slope (%)	6.7

Possible Solutions:

Remove & Replace Entire Ramp.

R304.5.3
