# Access Compliance Report

## Public Rights-of-Way

| Intersection ID: 4530 | Main Street: BROOKSHIRE_BV | Cross Street: MT_HOLLY-HUNTERSVILLE_RD | Location: | N |
| ADA ID: BF5C7A821308 | Ramp Type: Perp | Initial Pass/Fail: Fail | Overall Compliance: No | Severity Score: 8.75 |

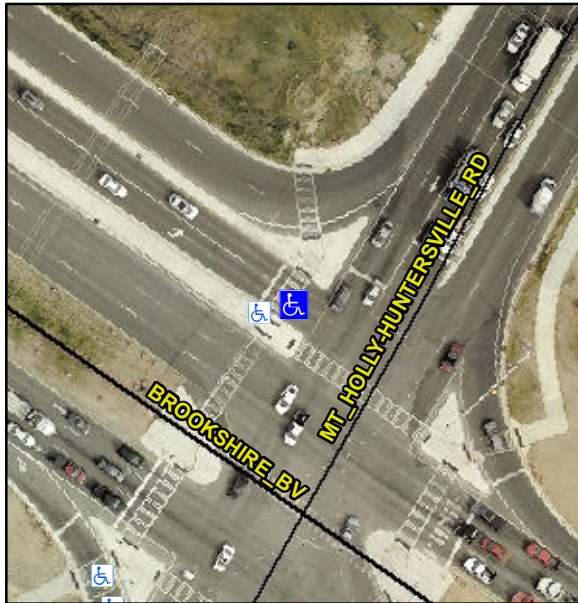
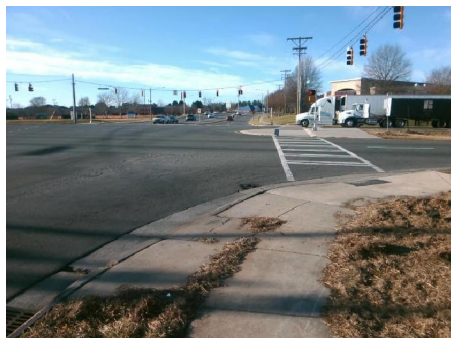
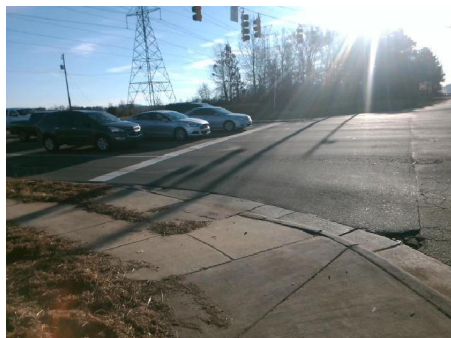
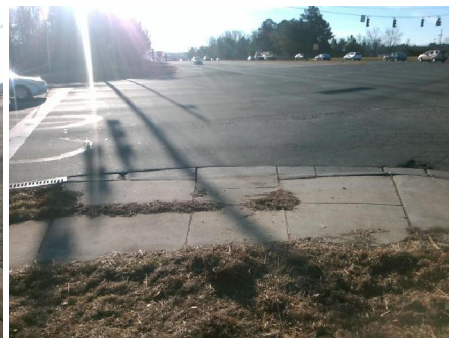
**R304.5.1**

| Compliance | Description | Data | Compliance | Description | Data |
|---|---|---|---|---|---|
| No | Ramp Width (in) | 45.0 | Yes | Ramp XSlope (%) | 0.4 |

**Remove & Replace Entire Ramp.**

**\$ 1850.00**
