Access Compliance Report

Public Rights-of-Way

(Curb Ramps)

Intersection ID: 12167	Main Street: SUNNYFIELD_CT	Cross Street: TIGER_LILY_LN	Location: SW
ADA ID: BF5F8F1A2933	Ramp Type: Perp	Initial Pass/Fail: Fail	Overall Compliance: No
Severity Score: 18.75			
Codes/Mitigation Info/Possible Solution		Field Measurements/Component Compliance

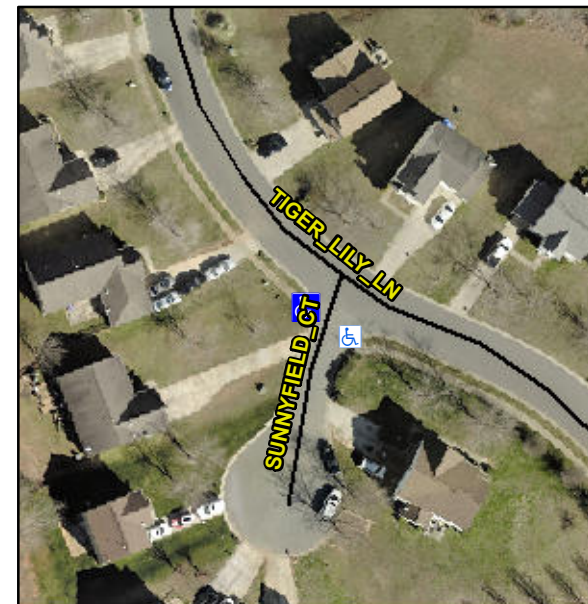
Not Found, R304.5.1, R304.5.3

Compliance	Description	Data	Compliance	Description	Data
N/A	Ramp Length (in)	49.5	Yes	Ramp Slope (%)	5.9
No	Ramp Width (in)	35.5	No	Ramp XSlope (%)	2.5
N/A	Flare Type LT	N/A	N/A	Flare Type RT	N/A
N/A	Flare Slope LT (%)	N/A	N/A	Flare Slope RT (%)	N/A
N/A	Flare Traversable LT?	N/A	N/A	Flare Traversable RT?	N/A
N/A	Landing Length (in)	N/A	N/A	DWS Provided?	N/A
N/A	Landing Width (in)	N/A	N/A	DWS Contrast?	N/A
N/A	Landing Slope (%)	N/A	N/A	DWS Length (in)	N/A
N/A	Landing X Slope (%)	N/A	N/A	DWS Full Width?	N/A
N/A	Landing Curb? (Y/N)	N/A	N/A	DWS Offset (in)	N/A
N/A	Shared Landing?	N/A			
N/A	Gutter Ponding?	N/A	N/A	Gutter Slope (%)	N/A
N/A	Gutter Lip Ht (in)	N/A	N/A	Gutter X Slope (%)	N/A
N/A	Painted X Walk1?	No	N/A	Painted X Walk2?	N/A
	X Walk 1 Direction	To SE		X Walk 2 Direction	N/A
N/A	X Walk 1 Width (in)	N/A	N/A	X Walk 2 Width (in)	N/A
	X Walk 1 Slope (%)	1.9		X Walk 2 Slope (%)	N/A
	X Walk 1 X Slope (%)	1.5		X Walk 2 X Slope (%)	N/A

Possible Solutions:

Remove & Replace Entire Ramp.

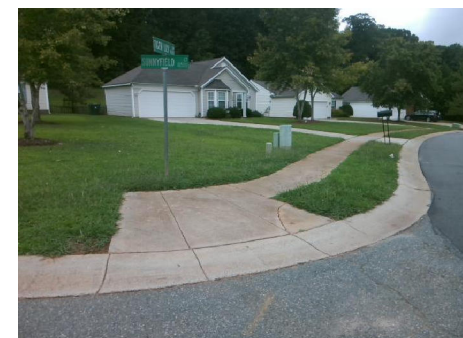
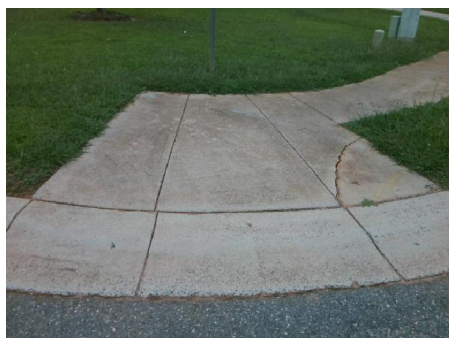
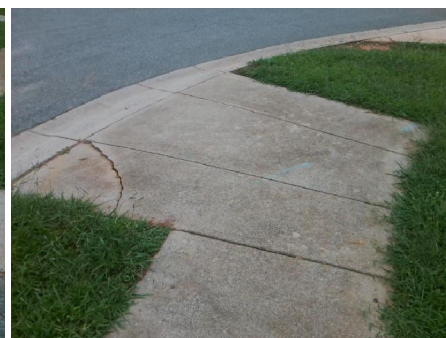
N/A	Ramp inside XWalk1?	N/A	N/A	Ramp inside XWalk2?	N/A
	Road Slope (%)	N/A	N/A	Clear Space?	N/A
	Road X Slope (%)	N/A	N/A	Clear Space to XWalk (in)	N/A
N/A	Any Obstructions?	N/A	N/A	Storm Grate/Utility Hazard?	N/A
	Obstruction Type			Storm Grate/Utility Type	
		N/A			N/A
			Yes	Surface Condition? (G/P)	Good
