# Access Compliance Report

## Public Rights-of-Way

### (Curb Ramps)

Intersection ID: 7901	Main Street: GLENMOOR_DR	Cross Street: LITTLE_ROCK_RD	Location:	N
ADA ID: BF741CD536E2	Ramp Type: Perp	Initial Pass/Fail: Fail	Overall Compliance: No	Severity Score: 21.25
Codes/Mitigation Info/Possible Solution		Field Measurements/Component Compliance

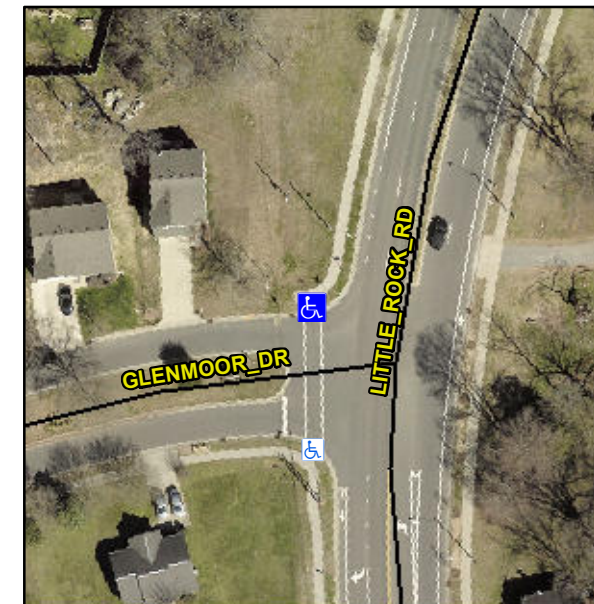
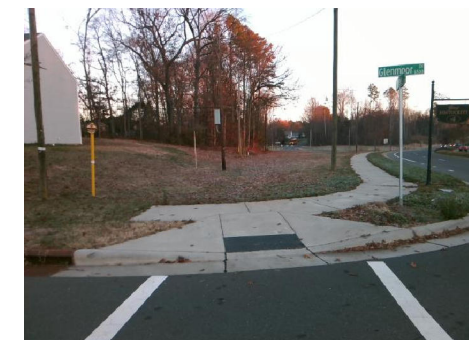
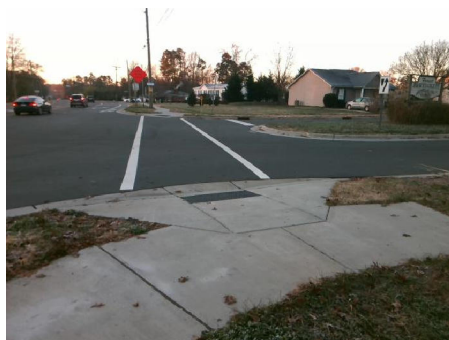
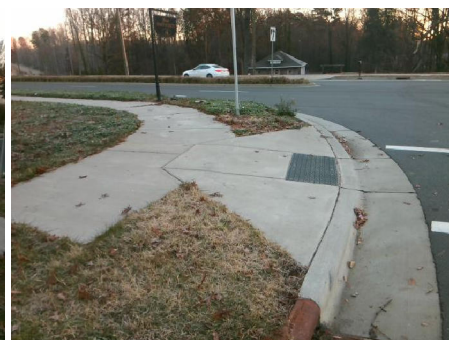
**Not Found, R304.5.1, R304.2.2**

Compliance	Description	Data	Compliance	Description	Data
N/A	Ramp Length (in)	63.0	No	Ramp Slope (%)	9.8
No	Ramp Width (in)	47.5	Yes	Ramp XSlope (%)	0.1
N/A	Flare Type LT	N/A	N/A	Flare Type RT	N/A
N/A	Flare Slope LT (%)	N/A	N/A	Flare Slope RT (%)	N/A
N/A	Flare Traversable LT?	N/A	N/A	Flare Traversable RT?	N/A
N/A	Landing Length (in)	N/A	N/A	DWS Provided?	N/A
N/A	Landing Width (in)	N/A	N/A	DWS Contrast?	N/A
N/A	Landing Slope (%)	N/A	N/A	DWS Length (in)	N/A
N/A	Landing X Slope (%)	N/A	N/A	DWS Full Width?	N/A
N/A	Landing Curb? (Y/N)	N/A	N/A	DWS Offset (in)	N/A
N/A	Shared Landing?	N/A			
N/A	Gutter Ponding?	N/A	N/A	Gutter Slope (%)	N/A
N/A	Gutter Lip Ht (in)	N/A	N/A	Gutter X Slope (%)	N/A
N/A	Painted X Walk1?	Yes	N/A	Painted X Walk2?	N/A
	X Walk 1 Direction	To S		X Walk 2 Direction	N/A
N/A	X Walk 1 Width (in)	97.5	N/A	X Walk 2 Width (in)	N/A
	X Walk 1 Slope (%)	1.6		X Walk 2 Slope (%)	N/A
	X Walk 1 X Slope (%)	0.3		X Walk 2 X Slope (%)	N/A

N/A	Ramp inside XWalk1?	Yes	N/A	Ramp inside XWalk2?	N/A
	Road Slope (%)	N/A	N/A	Clear Space?	N/A
	Road X Slope (%)	N/A	N/A	Clear Space to XWalk (in)	N/A
N/A	Any Obstructions?	N/A	N/A	Storm Grate/Utility Hazard?	N/A
	Obstruction Type			Storm Grate/Utility Type	
		N/A			N/A
		Yes		Surface Condition? (G/P)	Good

Possible Solutions:

**Remove & Replace Entire Ramp.**
