# Access Compliance Report

## Public Rights-of-Way

### (Curb Ramps)

Intersection ID: N/A	Main Street: KIMMERLY_GLEN_LN	Cross Street: N/A	Location: S
ADA ID: BF754F392732	Ramp Type: PerpDiag	Initial Pass/Fail: Fail	Overall Compliance: No
Codes/Mitigation Info/Possible Solution		Field Measurements/Component Compliance	
Severity Score: 25

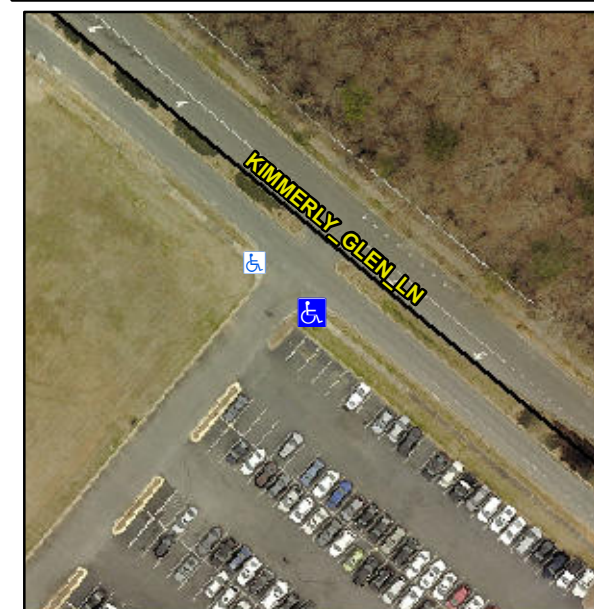
Compliance	Description	Data	Compliance	Description	Data
N/A	Ramp Length (in)	26.5	No	Ramp Slope (%)	9.5
Yes	Ramp Width (in)	51.0	No	Ramp XSlope (%)	6.0
N/A	Flare Type LT	N/A	N/A	Flare Type RT	N/A
N/A	Flare Slope LT (%)	N/A	N/A	Flare Slope RT (%)	N/A
N/A	Flare Traversable LT?	N/A	N/A	Flare Traversable RT?	N/A
N/A	Landing Length (in)	N/A	N/A	DWS Provided?	N/A
N/A	Landing Width (in)	N/A	N/A	DWS Contrast?	N/A
N/A	Landing Slope (%)	N/A	N/A	DWS Length (in)	N/A
N/A	Landing X Slope (%)	N/A	N/A	DWS Full Width?	N/A
N/A	Landing Curb? (Y/N)	N/A	N/A	DWS Offset (in)	N/A
N/A	Shared Landing?	N/A			
N/A	Gutter Ponding?	N/A	N/A	Gutter Slope (%)	N/A
N/A	Gutter Lip Ht (in)	N/A	N/A	Gutter X Slope (%)	N/A
N/A	Painted X Walk1?	No	N/A	Painted X Walk2?	No
	X Walk 1 Direction	To NE		X Walk 2 Direction	To NW
N/A	X Walk 1 Width (in)	N/A	N/A	X Walk 2 Width (in)	N/A
	X Walk 1 Slope (%)	5.6		X Walk 2 Slope (%)	7.2
	X Walk 1 X Slope (%)	4.3		X Walk 2 X Slope (%)	0.7

N/A	Ramp inside XWalk1?	N/A	N/A	Ramp inside XWalk2?	N/A
	Road Slope (%)	2.7	N/A	Clear Space?	N/A
	Road X Slope (%)	3.4	N/A	Clear Space to XWalk (in)	N/A
N/A	Any Obstructions?	N/A	N/A	Storm Grate/Utility Hazard?	N/A
	Obstruction Type			Storm Grate/Utility Type	
		N/A			N/A
			Yes	Surface Condition? (G/P)	Good

**Remove & Replace Curb Ramp With Two New Directional Ramps or Equivalent.**

**R304.2.2, R304.5.3**

Total Cost: \$ 3200.00
