# Access Compliance Report

## Public Rights-of-Way

### (Curb Ramps)

Intersection ID: 10015635	Main Street: HARRIS_CORNERS_PY	Cross Street: N/A	Location: W
ADA ID: BF8CCA9752DF	Ramp Type: BlendTrans2	Initial Pass/Fail: Fail	Overall Compliance: No
Severity Score: 8.75			
Codes/Mitigation Info/Possible Solution		Field Measurements/Component Compliance

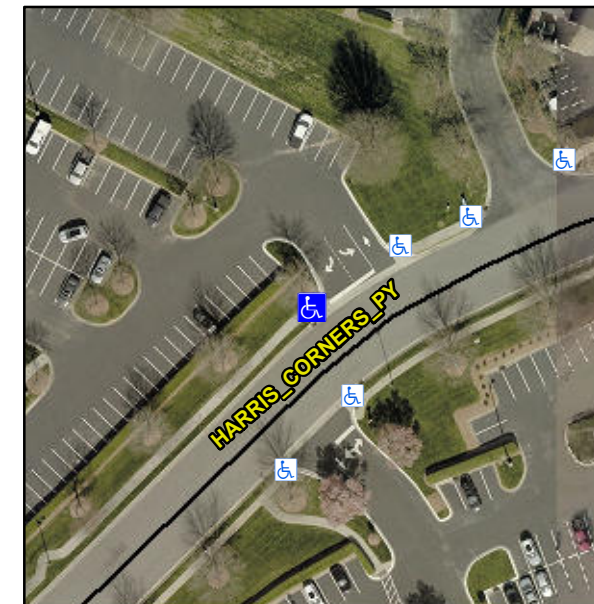
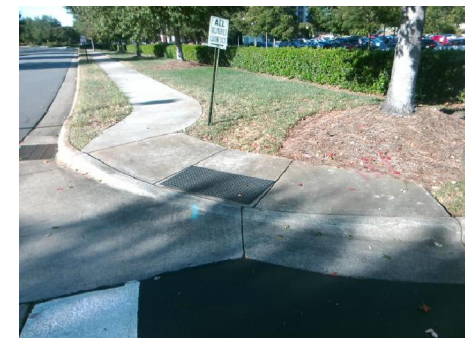
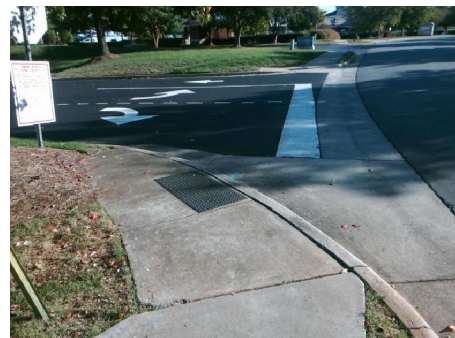
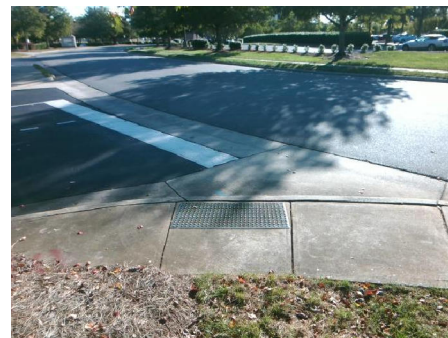
**Not Found, R304.5.1**

Compliance	Description	Data	Compliance	Description	Data
N/A	Ramp Length (in)	58.0	Yes	BlendTrans Slope (%)	3.4
No	Ramp Width (in)	42.0	Yes	BlendTrans XSlope (%)	1.2
N/A	Flare Type LT	N/A	N/A	Flare Type RT	N/A
N/A	Flare Slope LT (%)	N/A	N/A	Flare Slope RT (%)	N/A
N/A	Flare Traversable LT?	N/A	N/A	Flare Traversable RT?	N/A
N/A	Landing Length (in)	N/A	N/A	DWS Provided?	N/A
N/A	Landing Width (in)	N/A	N/A	DWS Contrast?	N/A
N/A	Landing Slope (%)	N/A	N/A	DWS Length (in)	N/A
N/A	Landing X Slope (%)	N/A	N/A	DWS Full Width?	N/A
N/A	Landing Curb? (Y/N)	N/A	N/A	DWS Offset (in)	N/A
N/A	Shared Landing?	N/A			
N/A	Gutter Ponding?	N/A	N/A	Gutter Slope (%)	N/A
N/A	Gutter Lip Ht (in)	N/A	N/A	Gutter X Slope (%)	N/A
N/A	Painted X Walk1?	No	N/A	Painted X Walk2?	No
	X Walk 1 Direction	To S		X Walk 2 Direction	To NE
	X Walk 1 Width (in)	N/A		X Walk 2 Width (in)	N/A
	X Walk 1 Slope (%)	0.9		X Walk 2 Slope (%)	0.5
	X Walk 1 X Slope (%)	0.2		X Walk 2 X Slope (%)	0.4

N/A	Ramp inside XWalk1?	N/A	N/A	Ramp inside XWalk2?	N/A
	Road Slope (%)	0.3		Clear Space?	N/A
	Road X Slope (%)	0.4	N/A	Clear Space to XWalk (in)	N/A
N/A	Any Obstructions?	N/A	N/A	Storm Grate/Utility Hazard?	N/A
	Obstruction Type			Storm Grate/Utility Type	
		N/A			N/A
			Yes	Surface Condition? (G/P)	Good
			No	Curb Slope (%)	7.1

Possible Solutions:

**Remove & Replace Curb Ramp With Two New Directional Ramps or Equivalent.**

Total Cost: \$ 3200.00
