# Access Compliance Report

## Public Rights-of-Way

### (Curb Ramps)

| Intersection ID: 44477 | Main Street: AINSWORTH_ST | Cross Street: WESTHOPE_ST | Location: SW |

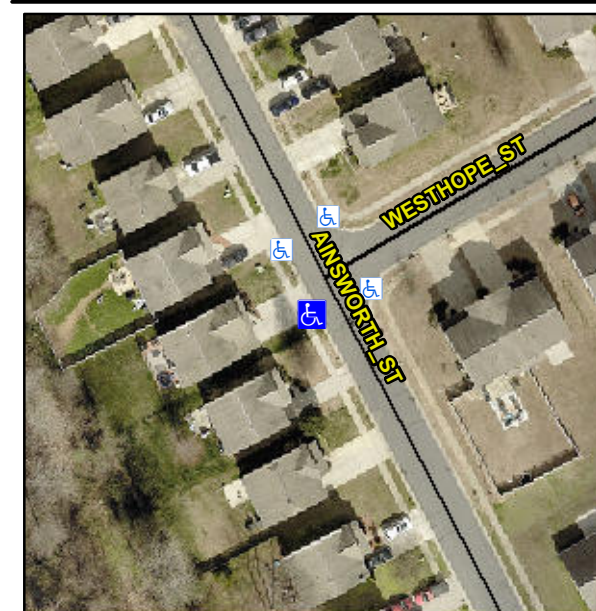
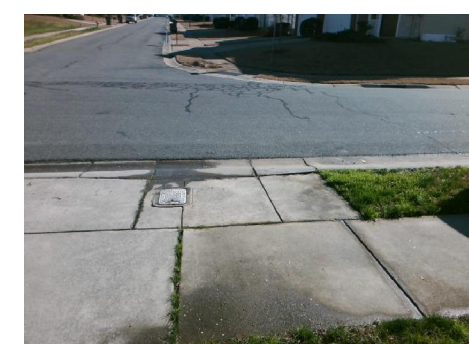
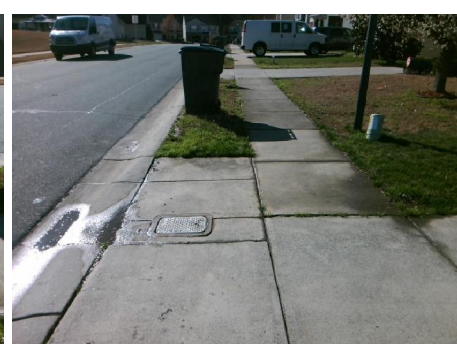
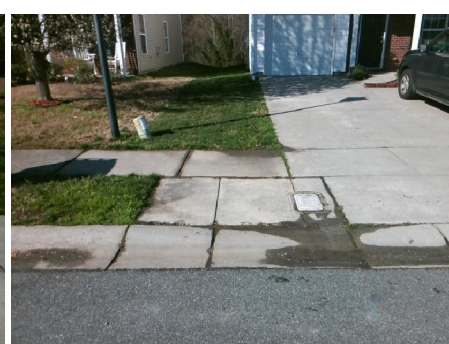
| ADA ID: BF8FC64F213F | Ramp Type: Perp | Initial Pass/Fail: Fail | Overall Compliance: No |
| Severity Score: 8.75 | | | |

**Not Found, R304.5.1**

| Compliance | Description | Data | Compliance | Description | Data |
|---|---|---|---|---|---|
| No | Ramp Width (in) | 46.5 | Yes | Ramp XSlope (%) | 1.1 |

**Remove & Replace Entire Ramp.**
