Access Compliance Report

Public Rights-of-Way

(Curb Ramps)

Intersection ID: 10025384	Main Street: E_9TH_ST	Cross Street: N/A	Location: SW
ADA ID: BF95A1E13B3B	Ramp Type: BlendTrans1	Initial Pass/Fail: Pass	Overall Compliance: No
		Severity Score: 0

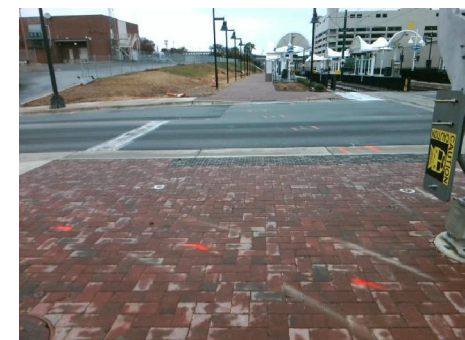
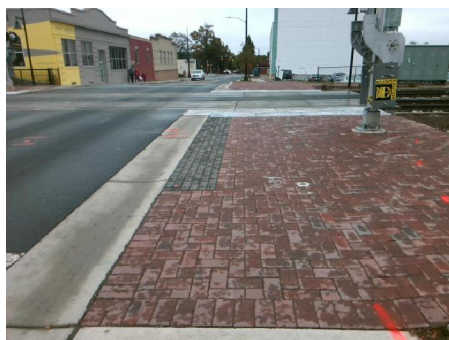
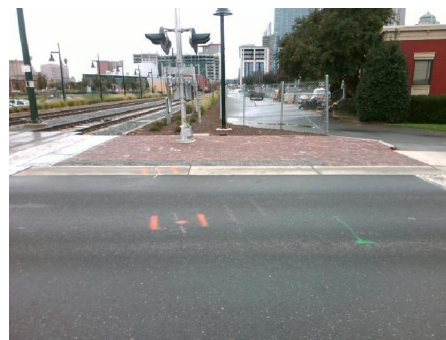
Compliance	Description	Data	Compliance	Description	Data
N/A	Ramp Length (in)	78.0	Yes	BlendTrans Slope (%)	0.9
Yes	Ramp Width (in)	96.0	Yes	BlendTrans XSlope (%)	0.8
N/A	Flare Type LT	None	N/A	Flare Type RT	None
N/A	Flare Slope LT (%)	N/A	N/A	Flare Slope RT (%)	N/A
N/A	Flare Traversable LT?	N/A	N/A	Flare Traversable RT?	N/A
Yes	Landing Length (in)	109.0	Yes	DWS Provided?	Yes
Yes	Landing Width (in)	96.0	Yes	DWS Contrast?	Yes
Yes	Landing Slope (%)	1.6	Yes	DWS Length (in)	24.0
Yes	Landing X Slope (%)	1.1	Yes	DWS Full Width?	Yes
N/A	Landing Curb? (Y/N)	No	Yes	DWS Offset (in)	0.0
N/A	Shared Landing?	Yes			
Yes	Gutter Ponding?	No	Yes	Gutter Slope (%)	0.7
Yes	Gutter Lip Ht (in)	0.0	Yes	Gutter X Slope (%)	1.2
N/A	Painted X Walk1?	No	N/A	Painted X Walk2?	N/A
	X Walk 1 Direction	To NE		X Walk 2 Direction	N/A
	X Walk 1 Width (in)	N/A		X Walk 2 Width (in)	N/A
	X Walk 1 Slope (%)	1.6		X Walk 2 Slope (%)	N/A
	X Walk 1 X Slope (%)	1.2		X Walk 2 X Slope (%)	N/A

N/A	Ramp inside XWalk1?	N/A	N/A	Ramp inside XWalk2?	N/A
	Road Slope (%)	1.2		Clear Space?	Yes
	Road X Slope (%)	1.6	N/A	Clear Space to XWalk (in)	N/A
Yes	Any Obstructions?	No	Yes	Storm Grate/Utility Hazard?	No
	Obstruction Type			Storm Grate/Utility Type	
		N/A			N/A
			Yes	Surface Condition? (G/P)	Good
			No	Curb Slope (%)	11.9

Remove & Replace Curb Slope and Extend Ramp.
