# Access Compliance Report

## Public Rights-of-Way

### (Curb Ramps)

Intersection ID: 47570	Main Street: HERMSLEY_RD	Cross Street: GAILES_DR	Location: SE
ADA ID: BFA62E08EC7F	Ramp Type: PerpDiag	Initial Pass/Fail: Fail	Overall Compliance: No
Severity Score: 21.25			
Codes/Mitigation Info/Possible Solution		Field Measurements/Component Compliance

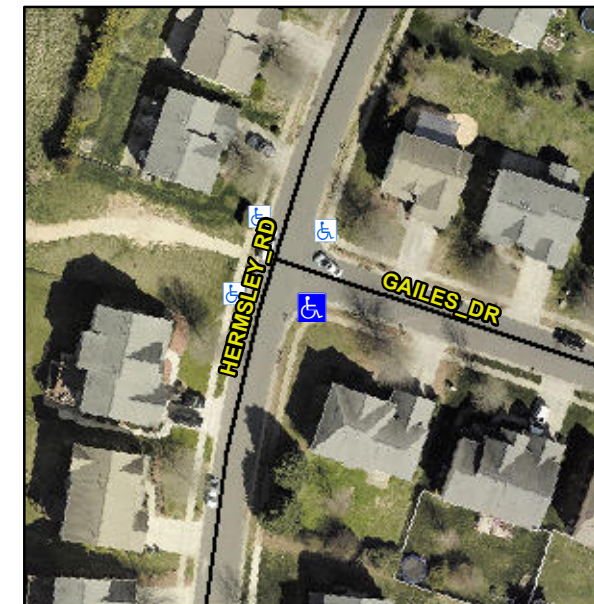
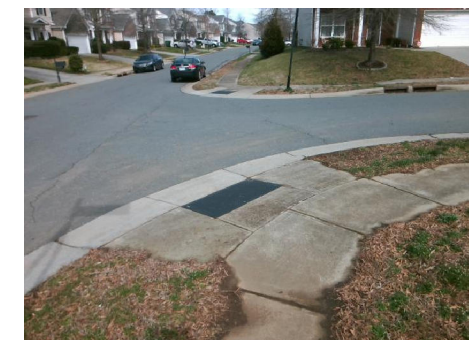
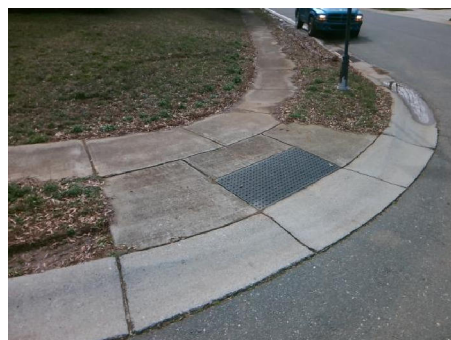
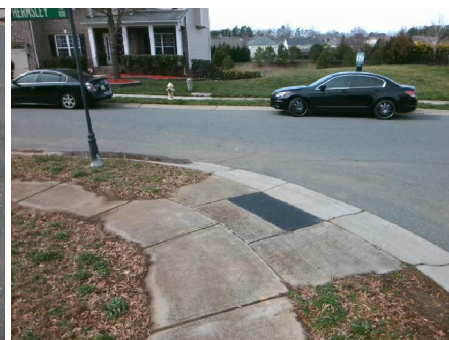
Compliance	Description	Data	Compliance	Description	Data
N/A	Ramp Length (in)	46.0	No	Ramp Slope (%)	9.8
No	Ramp Width (in)	46.0	Yes	Ramp XSlope (%)	0.3
N/A	Flare Type LT	N/A	N/A	Flare Type RT	N/A
N/A	Flare Slope LT (%)	N/A	N/A	Flare Slope RT (%)	N/A
N/A	Flare Traversable LT?	N/A	N/A	Flare Traversable RT?	N/A
N/A	Landing Length (in)	N/A	N/A	DWS Provided?	N/A
N/A	Landing Width (in)	N/A	N/A	DWS Contrast?	N/A
N/A	Landing Slope (%)	N/A	N/A	DWS Length (in)	N/A
N/A	Landing X Slope (%)	N/A	N/A	DWS Full Width?	N/A
N/A	Landing Curb? (Y/N)	N/A	N/A	DWS Offset (in)	N/A
N/A	Shared Landing?	N/A			
N/A	Gutter Ponding?	N/A	N/A	Gutter Slope (%)	N/A
N/A	Gutter Lip Ht (in)	N/A	N/A	Gutter X Slope (%)	N/A
N/A	Painted X Walk1?	No	N/A	Painted X Walk2?	No
	X Walk 1 Direction	To NE		X Walk 2 Direction	To NW
N/A	X Walk 1 Width (in)	N/A	N/A	X Walk 2 Width (in)	N/A
	X Walk 1 Slope (%)	1.0		X Walk 2 Slope (%)	1.6
	X Walk 1 X Slope (%)	2.6		X Walk 2 X Slope (%)	1.4

N/A	Ramp inside XWalk1?	N/A	N/A	Ramp inside XWalk2?	N/A
	Road Slope (%)	0.4	N/A	Clear Space?	N/A
	Road X Slope (%)	4.7	N/A	Clear Space to XWalk (in)	N/A
N/A	Any Obstructions?	N/A	N/A	Storm Grate/Utility Hazard?	N/A
	Obstruction Type			Storm Grate/Utility Type	
		N/A			N/A
			Yes	Surface Condition? (G/P)	Good

**Remove & Replace Curb Ramp With Two New Directional Ramps or Equivalent.**

**R304.5.1, R304.2.2**
