Access Compliance Report Public Rights-of-Way (Curb Ramps)

Intersection ID: 10038783 Main Street: STEELE CREEK RD **Cross Street: N/A** Location: SW ADA ID: BFB0ECE85191 Ramp Type: PerpDiag Initial Pass/Fail: Fail **Overall Compliance: No Severity Score:** 22.5

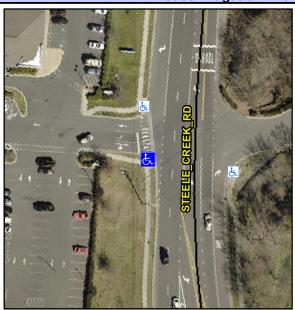
Field Measurements/Component Compliance							
	Compliance Description		Data	Compliance Description		Data	
	N/A	Ramp Length (in)	58.0	No	Ramp	Slope (%)	10.1
	No	Ramp Width (in)	47.0	No	Ramp	XSlope (%)	2.3
	N/A	Flare Type LT	N/A	N/A	Flare	Type RT	N/A
	N/A	Flare Slope LT (%)	N/A	N/A	Flare	Slope RT (%)	N/A
	N/A	Flare Traversable LT?	N/A	N/A	Flare	Traversable RT?	N/A
	N/A	Landing Length (in)	N/A	N/A	DWS	Provided?	N/A
	N/A	Landing Width (in)	N/A	N/A	DWS	Contrast?	N/A
	N/A	Landing Slope (%)	N/A	N/A	DWS	Length (in)	N/A
	N/A	Landing X Slope (%)	N/A	N/A	DWS	Full Width?	N/A
	N/A	Landing Curb? (Y/N)	N/A	N/A	DWS	Offset (in)	N/A
	N/A	Shared Landing?	N/A				
	N/A	Gutter Ponding?	N/A	N/A	Gutte	r Slope (%)	N/A
	N/A	Gutter Lip Ht (in)	N/A	N/A	Gutte	r X Slope (%)	N/A
	N/A	Painted X Walk1?	No	N/A	Painte	ed X Walk2?	Yes
		X Walk 1 Direction	To SE		X Wal	lk 2 Direction	To N
	N/A	X Walk 1 Width (in)	N/A	N/A	X Wal	lk 2 Width (in)	94.0

X Walk 1 Slope (%)	1.3		X Wal	lk 2 Slope (%)	1.5
		X Walk 1 X Slope (%)	1.2		X Wal	lk 2 X Slope (%)	8.6
	N/A	Ramp inside XWalk1?	N/A	N/A	Ramp	inside XWalk2?	Yes
		Road Slope (%)	1.5	N/A	Clear	Space?	N/A
		Road X Slope (%)	11.2	N/A	Clear	Space to XWalk (in)	N/A
	N/A	Any Obstructions?	N/A	N/A	Storm	Grate/Utility Hazard?	N/A
		Obstruction Type			Storm	Grate/Utility Type	
			N/A				N/A
				Yes	Surfac	ce Condition? (G/P)	Good
	軍	AL AL A

Possible Solutions: **Remove & Replace Curb Ramp With Two New Directional Ramps or** Equivalent. Surveyor Notes: N/A PROW/ADA: Not Found, R304.5.1, R304.2.2, R304.5.3
