Access Compliance Report

Public Rights-of-Way

(Curb Ramps)

Intersection ID: 9255	Main Street: BOOKER_AV	Cross Street: CAMPUS_ST	Location: SW
ADA ID: BFB6BACC6136	Ramp Type: BlendTrans1	Initial Pass/Fail: Fail	Overall Compliance: No
			Severity Score: 18.75

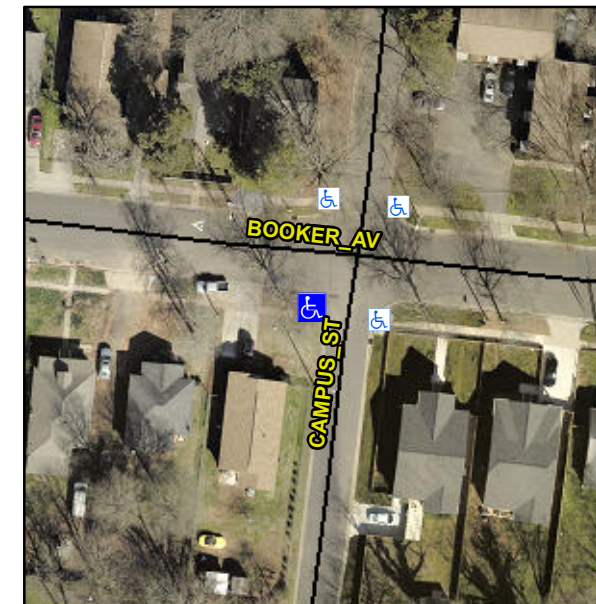
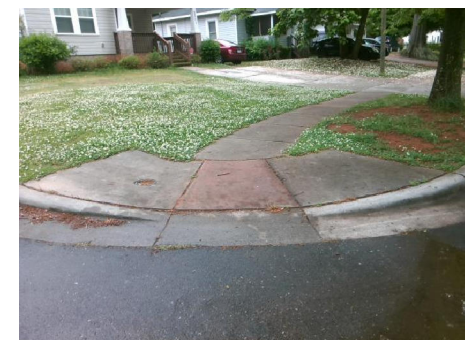
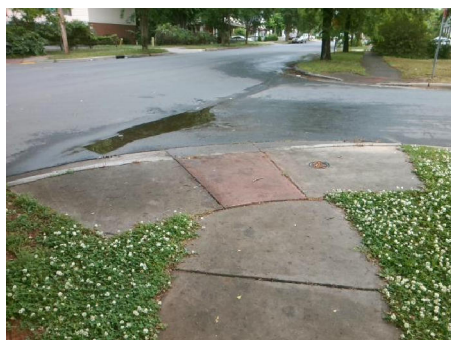
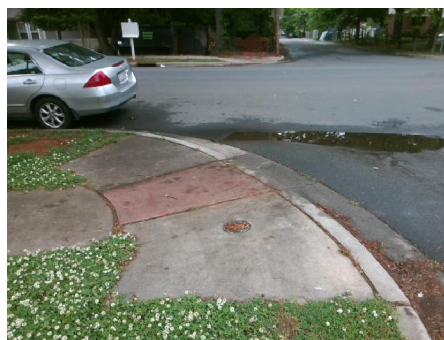
Not Found, R304.5.1, R304.5.3

Compliance	Description	Data	Compliance	Description	Data
N/A	Ramp Length (in)	59.5	Yes	BlendTrans Slope (%)	2.7
No	Ramp Width (in)	32.0	No	BlendTrans XSlope (%)	3.2
N/A	Flare Type LT	N/A	N/A	Flare Type RT	N/A
N/A	Flare Slope LT (%)	N/A	N/A	Flare Slope RT (%)	N/A
N/A	Flare Traversable LT?	N/A	N/A	Flare Traversable RT?	N/A
N/A	Landing Length (in)	N/A	N/A	DWS Provided?	N/A
N/A	Landing Width (in)	N/A	N/A	DWS Contrast?	N/A
N/A	Landing Slope (%)	N/A	N/A	DWS Length (in)	N/A
N/A	Landing X Slope (%)	N/A	N/A	DWS Full Width?	N/A
N/A	Landing Curb? (Y/N)	N/A	N/A	DWS Offset (in)	N/A
N/A	Shared Landing?	N/A			
N/A	Gutter Ponding?	N/A	N/A	Gutter Slope (%)	N/A
N/A	Gutter Lip Ht (in)	N/A	N/A	Gutter X Slope (%)	N/A
N/A	Painted X Walk1?	No	N/A	Painted X Walk2?	No
	X Walk 1 Direction	To E		X Walk 2 Direction	To N
	X Walk 1 Width (in)	N/A		X Walk 2 Width (in)	N/A
	X Walk 1 Slope (%)	1.9		X Walk 2 Slope (%)	3.2
	X Walk 1 X Slope (%)	3.3		X Walk 2 X Slope (%)	0.9

N/A	Ramp inside XWalk1?	N/A	N/A	Ramp inside XWalk2?	N/A
	Road Slope (%)	2.0		Clear Space?	N/A
	Road X Slope (%)	3.9	N/A	Clear Space to XWalk (in)	N/A
N/A	Any Obstructions?	N/A	N/A	Storm Grate/Utility Hazard?	N/A
	Obstruction Type			Storm Grate/Utility Type	
		N/A			N/A
			Yes	Surface Condition? (G/P)	Good
			No	Curb Slope (%)	12.2

Remove & Replace Curb Ramp With Two New Directional Ramps or Equivalent.
