Access Compliance Report

Public Rights-of-Way

(Curb Ramps)

Intersection ID: 28912	Main Street: BURKHARD_WY	Cross Street: SPRINGBANK_LN	Location: SW
ADA ID: BFB848BAAC8F	Ramp Type: PerpDiag	Initial Pass/Fail: Fail	Overall Compliance: No
		Severity Score: 12.5

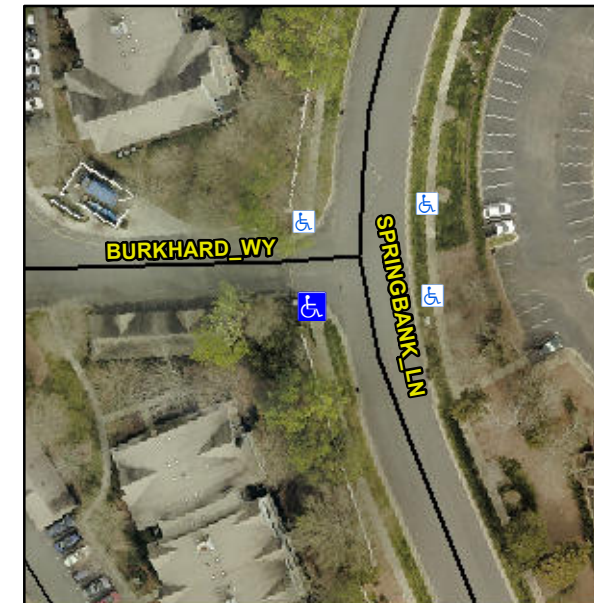
Compliance	Description	Data	Compliance	Description	Data
N/A	Ramp Length (in)	80.0	Yes	Ramp Slope (%)	8.3
Yes	Ramp Width (in)	58.0	No	Ramp XSlope (%)	6.9
N/A	Flare Type LT	N/A	N/A	Flare Type RT	N/A
N/A	Flare Slope LT (%)	N/A	N/A	Flare Slope RT (%)	N/A
N/A	Flare Traversable LT?	N/A	N/A	Flare Traversable RT?	N/A
N/A	Landing Length (in)	N/A	N/A	DWS Provided?	N/A
N/A	Landing Width (in)	N/A	N/A	DWS Contrast?	N/A
N/A	Landing Slope (%)	N/A	N/A	DWS Length (in)	N/A
N/A	Landing X Slope (%)	N/A	N/A	DWS Full Width?	N/A
N/A	Landing Curb? (Y/N)	N/A	N/A	DWS Offset (in)	N/A
N/A	Shared Landing?	N/A			
N/A	Gutter Ponding?	N/A	N/A	Gutter Slope (%)	N/A
N/A	Gutter Lip Ht (in)	N/A	N/A	Gutter X Slope (%)	N/A
N/A	Painted X Walk1?	No	N/A	Painted X Walk2?	No
	X Walk 1 Direction	To E		X Walk 2 Direction	To N
N/A	X Walk 1 Width (in)	N/A	N/A	X Walk 2 Width (in)	N/A
	X Walk 1 Slope (%)	10.5		X Walk 2 Slope (%)	3.8
	X Walk 1 X Slope (%)	1.6		X Walk 2 X Slope (%)	2.8

N/A	Ramp inside XWalk1?	N/A	N/A	Ramp inside XWalk2?	N/A
	Road Slope (%)	0.9	N/A	Clear Space?	N/A
	Road X Slope (%)	8.3	N/A	Clear Space to XWalk (in)	N/A
N/A	Any Obstructions?	N/A	N/A	Storm Grate/Utility Hazard?	N/A
	Obstruction Type			Storm Grate/Utility Type	
		N/A			N/A
		Yes		Surface Condition? (G/P)	Good

Remove & Replace Curb Ramp With Two New Directional Ramps or Equivalent.
