# Access Compliance Report

## Public Rights-of-Way

| Intersection ID: 25725 | Main Street: PARK_RD | Cross Street: HUNTER_RIDGE_DR | Location: NE |
| ADA ID: BFBD6CE21244 | Ramp Type: PerpDiag | Initial Pass/Fail: Fail | Overall Compliance: No |

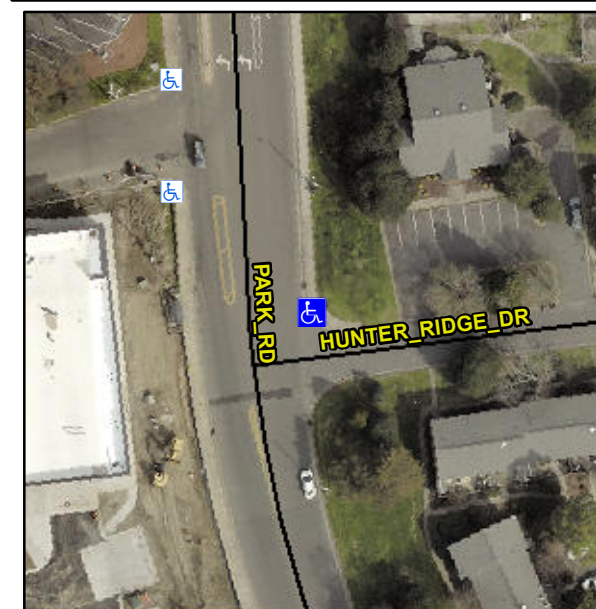
| Severity Score: 21.25 | | | |

**Not Found, R304.5.1, R304.2.2**

| Compliance | Description | Data | Compliance | Description | Data |
|---|---|---|---|---|---|
| N/A | Ramp Length (in) | 60.0 | No | Ramp Slope (%) | 11.2 |
| No | Ramp Width (in) | 42.0 | Yes | Ramp XSlope (%) | 0.7 |

**Remove & Replace Curb Ramp With Two New Directional Ramps or Equivalent.**

Total Cost: \$ 3200.00
