Access Compliance Report

Public Rights-of-Way

(Curb Ramps)

Intersection ID: 16897	Main Street: MONTAGUE_ST	Cross Street: SUMMEY_AV	Location: S
ADA ID: BFC2C5601F17	Ramp Type: ParaDiag	Initial Pass/Fail: Fail	Overall Compliance: No
			Severity Score: 21.25

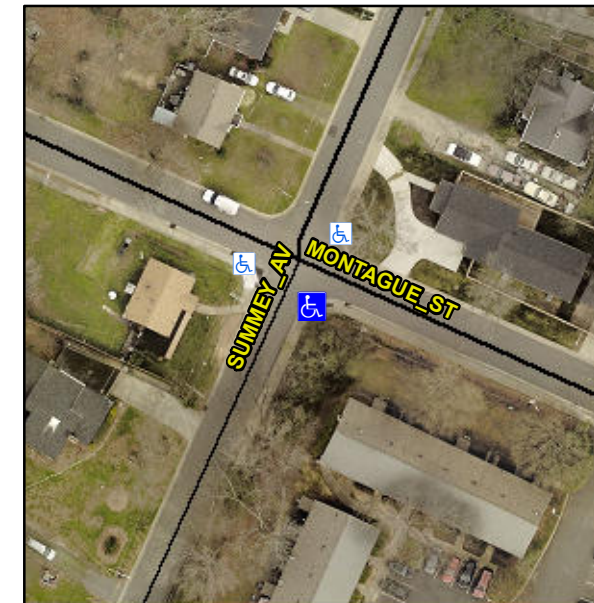
RT RP < 5%,

R304.5.1, R304.3.2

Compliance	Description	Data	Compliance	Description	Data
N/A	Ramp Length LT (in)	69.0	N/A	Ramp Length RT (in)	64.0
Yes	Ramp Width LT (in)	48.0	No	Ramp Width RT (in)	47.0
No	Ramp Slope LT (%)	10.0	Yes	Ramp Slope RT (%)	2.5
Yes	Ramp XSlope LT (%)	0.0	Yes	Ramp XSlope RT (%)	1.9
N/A	Landing Length (in)	N/A	N/A	DWS Provided?	N/A
N/A	Landing Width (in)	N/A	N/A	DWS Contrast?	N/A
N/A	Landing Slope (%)	N/A	N/A	DWS Length (in)	N/A
N/A	Landing X Slope (%)	N/A	N/A	DWS Full Width?	N/A
N/A	Landing Curb? (Y/N)	N/A	N/A	DWS Offset (in)	N/A
N/A	Shared Landing?	N/A			
N/A	Gutter Ponding?	N/A	N/A	Gutter Slope (%)	N/A
N/A	Gutter Lip Ht (in)	N/A	N/A	Gutter X Slope (%)	N/A
N/A	Painted X Walk1?	No	N/A	Painted X Walk2?	No
	X Walk 1 Direction	To NE		X Walk 2 Direction	To NW
N/A	X Walk 1 Width (in)	N/A	N/A	X Walk 2 Width (in)	N/A
	X Walk 1 Slope (%)	3.7		X Walk 2 Slope (%)	2.1
	X Walk 1 X Slope (%)	3.1		X Walk 2 X Slope (%)	7.1
N/A	Ramp inside XWalk1?	N/A	N/A	Ramp inside XWalk2?	N/A

Road Slope (%)	5.7	N/A	Clear Space?	N/A
	Road X Slope (%)	9.9	N/A	Clear Space to XWalk (in)	N/A
N/A	Any Obstructions?	N/A	N/A	Storm Grate/Utility Hazard?	N/A
	Obstruction Type			Storm Grate/Utility Type	
		N/A			N/A
			Yes	Surface Condition? (G/P)	Good
			N/A	Curb Slope (%)	13.4

Remove & Replace Curb Ramp With Two New Directional Ramps or Equivalent.
