Access Compliance Report

Public Rights-of-Way

(Curb Ramps)

Intersection ID: 10026308	Main Street: FAIRVIEW_RD	Cross Street: N/A	Location: SE
ADA ID: BFC7C77775E0	Ramp Type: PerpDiag	Initial Pass/Fail: Fail	Overall Compliance: No
Codes/Mitigation Info/Possible Solution		Field Measurements/Component Compliance	
Severity Score: 12.5

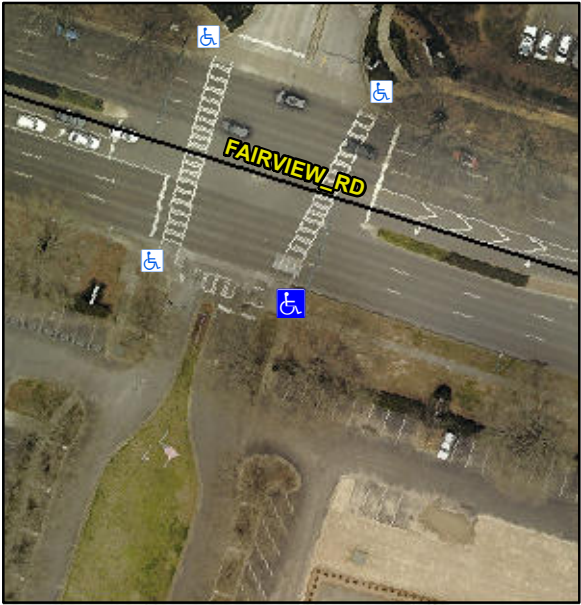
Compliance	Description	Data	Compliance	Description	Data
N/A	Ramp Length (in)	64.0	No	Ramp Slope (%)	8.6
Yes	Ramp Width (in)	48.0	Yes	Ramp XSlope (%)	1.0
N/A	Flare Type LT	N/A	N/A	Flare Type RT	N/A
N/A	Flare Slope LT (%)	N/A	N/A	Flare Slope RT (%)	N/A
N/A	Flare Traversable LT?	N/A	N/A	Flare Traversable RT?	N/A
N/A	Landing Length (in)	N/A	N/A	DWS Provided?	N/A
N/A	Landing Width (in)	N/A	N/A	DWS Contrast?	N/A
N/A	Landing Slope (%)	N/A	N/A	DWS Length (in)	N/A
N/A	Landing X Slope (%)	N/A	N/A	DWS Full Width?	N/A
N/A	Landing Curb? (Y/N)	N/A	N/A	DWS Offset (in)	N/A
N/A	Shared Landing?	N/A			
N/A	Gutter Ponding?	N/A	N/A	Gutter Slope (%)	N/A
N/A	Gutter Lip Ht (in)	N/A	N/A	Gutter X Slope (%)	N/A
N/A	Painted X Walk1?	Yes	N/A	Painted X Walk2?	Yes
	X Walk 1 Direction	To NE		X Walk 2 Direction	To NW
N/A	X Walk 1 Width (in)	106.0	N/A	X Walk 2 Width (in)	101.0
	X Walk 1 Slope (%)	2.0		X Walk 2 Slope (%)	2.9
	X Walk 1 X Slope (%)	2.3		X Walk 2 X Slope (%)	1.1

N/A	Ramp inside XWalk1?	Yes	N/A	Ramp inside XWalk2?	Yes
	Road Slope (%)	0.5	N/A	Clear Space?	N/A
	Road X Slope (%)	3.9	N/A	Clear Space to XWalk (in)	N/A
N/A	Any Obstructions?	N/A	N/A	Storm Grate/Utility Hazard?	N/A
	Obstruction Type			Storm Grate/Utility Type	
		N/A			N/A
		Yes		Surface Condition? (G/P)	Good

Possible Solutions:			
	Remove & Replace Curb Ramp With Two New Directional Ramps or Equivalent.			
	Surveyor Notes:			
	N/A			
	PROW/ADA:			
	R304.2.2			
	Total Cost:	\$	3200.00	
Street 1 Name	FAIRVIEW RD			
Stop Condition-Street 2	Signal			
Street 2 Name	ENTRANCE			
Stop Condition-Street 1	Signal
