# Access Compliance Report

## Public Rights-of-Way

### (Curb Ramps)

| Intersection ID: 44471 | Main Street: COREY_COMMON_AV | Cross Street: REDDING_GLEN_AV | Location: NE |

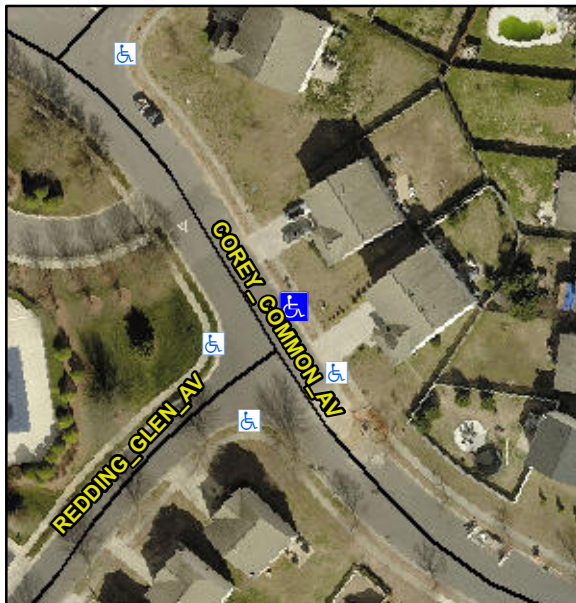
**Not Found, R304.2.2, R304.5.3,  
R304.2.1, R304.2.2-Perp, R304.3.2-  
Para, R302.7.2, R304.5.4**

| Compliance | Description | Data | Compliance | Description | Data |
|---|---|---|---|---|---|
| N/A | Ramp Length (in) | 48.0 | No | Ramp Slope (%) | 9.1 |
| Yes | Ramp Width (in) | 48.0 | No | Ramp XSlope (%) | 2.2 |

Possible Solutions:

**Remove & Replace Entire Ramp.  
Remove & Replace Gutter.**
