# Access Compliance Report

## Public Rights-of-Way

### (Curb Ramps)

Intersection ID: 10019902	Main Street: ARCO_CORPORATE_DR	Cross Street: N/A	Location: N
ADA ID: BFC9F363627B	Ramp Type: PerpDiag	Initial Pass/Fail: Fail	Overall Compliance: No
Severity Score: 21.25			
Codes/Mitigation Info/Possible Solution		Field Measurements/Component Compliance

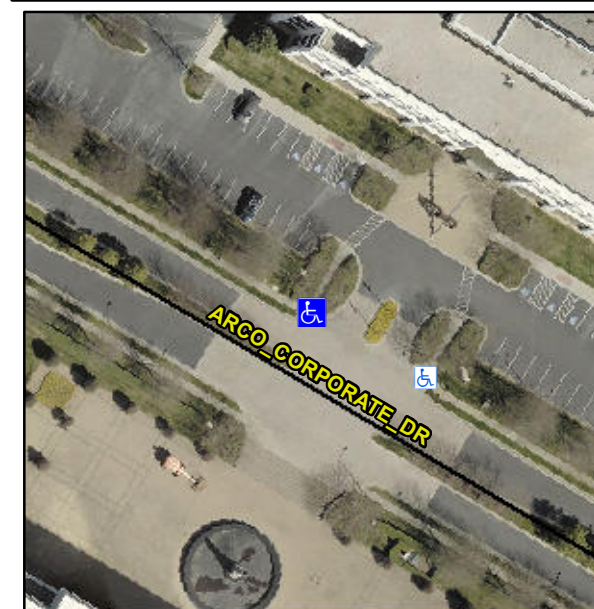
**R304.5.1, R304.2.2**

Compliance	Description	Data	Compliance	Description	Data
N/A	Ramp Length (in)	52.0	No	Ramp Slope (%)	10.1
No	Ramp Width (in)	42.0	Yes	Ramp XSlope (%)	1.7
N/A	Flare Type LT	N/A	N/A	Flare Type RT	N/A
N/A	Flare Slope LT (%)	N/A	N/A	Flare Slope RT (%)	N/A
N/A	Flare Traversable LT?	N/A	N/A	Flare Traversable RT?	N/A
N/A	Landing Length (in)	N/A	N/A	DWS Provided?	N/A
N/A	Landing Width (in)	N/A	N/A	DWS Contrast?	N/A
N/A	Landing Slope (%)	N/A	N/A	DWS Length (in)	N/A
N/A	Landing X Slope (%)	N/A	N/A	DWS Full Width?	N/A
N/A	Landing Curb? (Y/N)	N/A	N/A	DWS Offset (in)	N/A
N/A	Shared Landing?	N/A			
N/A	Gutter Ponding?	N/A	N/A	Gutter Slope (%)	N/A
N/A	Gutter Lip Ht (in)	N/A	N/A	Gutter X Slope (%)	N/A
N/A	Painted X Walk1?	No	N/A	Painted X Walk2?	No
	X Walk 1 Direction	To SW		X Walk 2 Direction	To SE
N/A	X Walk 1 Width (in)	N/A	N/A	X Walk 2 Width (in)	N/A
	X Walk 1 Slope (%)	3.0		X Walk 2 Slope (%)	3.1
	X Walk 1 X Slope (%)	1.5		X Walk 2 X Slope (%)	0.9

N/A	Ramp inside XWalk1?	N/A	N/A	Ramp inside XWalk2?	N/A
	Road Slope (%)	2.5	N/A	Clear Space?	N/A
	Road X Slope (%)	3.2	N/A	Clear Space to XWalk (in)	N/A
N/A	Any Obstructions?	N/A	N/A	Storm Grate/Utility Hazard?	N/A
	Obstruction Type			Storm Grate/Utility Type	
		N/A			N/A
			Yes	Surface Condition? (G/P)	Good

**Remove & Replace Curb Ramp With Two New Directional Ramps or Equivalent.**

Total Cost: \$ 3200.00
