# Access Compliance Report

## Public Rights-of-Way

### (Curb Ramps)

| Intersection ID: 14477 | Main Street: WEDDINGTON_AV | Cross Street: BASCOM_ST | Location: S |

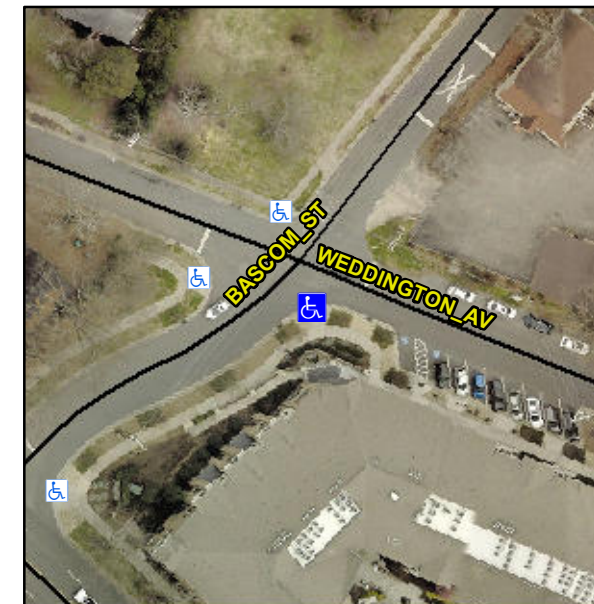
**R304.5.3, R304.2.2-Perp, R304.3.2-Para, R305.2**

| Compliance | Description | Data | Compliance | Description | Data |
|---|---|---|---|---|---|
| Yes | Ramp Width (in) | 48.0 | No | Ramp XSlope (%) | 3.7 |
| No | Landing Slope (%) | 2.6 | Yes | DWS Length (in) | 24.0 |
| N/A | Landing Curb? (Y/N) | No | No | DWS Offset (in) | 5.0 |
| Yes | Gutter Lip Ht (in) | 0.0 | No | Gutter X Slope (%) | 2.8 |

**Remove & Replace Curb Ramp With Two New Directional Ramps or Equivalent. Remove & Replace Gutter.**
