Access Compliance Report

Public Rights-of-Way

(Curb Ramps)

Intersection ID: 49894	Main Street: ROCKY_FORD_CLUB_RD	Cross Street: RUTH_FERRELL_CT	Location: NE
ADA ID: BFCF10998600	Ramp Type: Perp	Initial Pass/Fail: Pass	Overall Compliance: No
Codes/Mitigation Info/Possible Solution		Field Measurements/Component Compliance	
Severity Score: 7.75

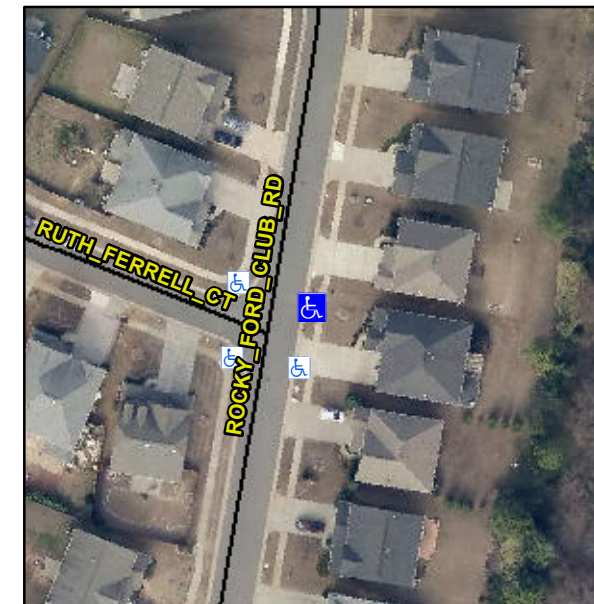
**Not Found, R304.5.3, R305.2,
R302.7.2**

Compliance	Description	Data	Compliance	Description	Data
N/A	Ramp Length (in)	72.0	Yes	Ramp Slope (%)	6.4
Yes	Ramp Width (in)	48.0	No	Ramp XSlope (%)	2.2
N/A	Flare Type LT	Sloped	N/A	Flare Type RT	N/A
N/A	Flare Slope LT (%)	6.8	Yes	Flare Slope RT (%)	9.5
N/A	Flare Traversable LT?	Yes	N/A	Flare Traversable RT?	Yes
Yes	Landing Length (in)	48.0	Yes	DWS Provided?	Yes
Yes	Landing Width (in)	48.0	Yes	DWS Contrast?	Yes
Yes	Landing Slope (%)	1.5	Yes	DWS Length (in)	24.5
Yes	Landing X Slope (%)	0.8	Yes	DWS Full Width?	Yes
N/A	Landing Curb? (Y/N)	No	No	DWS Offset (in)	5.5
N/A	Shared Landing?	No			
Yes	Gutter Ponding?	No	Yes	Gutter Slope (%)	3.4
No	Gutter Lip Ht (in)	0.5	No	Gutter X Slope (%)	2.2
N/A	Painted X Walk1?	No	N/A	Painted X Walk2?	N/A
	X Walk 1 Direction	To W		X Walk 2 Direction	N/A
N/A	X Walk 1 Width (in)	N/A	N/A	X Walk 2 Width (in)	N/A
	X Walk 1 Slope (%)	0.7		X Walk 2 Slope (%)	N/A
	X Walk 1 X Slope (%)	0.9		X Walk 2 X Slope (%)	N/A

N/A	Ramp inside XWalk1?	N/A	N/A	Ramp inside XWalk2?	N/A
	Road Slope (%)	N/A	N/A	Clear Space?	Yes
	Road X Slope (%)	N/A	N/A	Clear Space to XWalk (in)	N/A
Yes	Any Obstructions?	No	Yes	Storm Grate/Utility Hazard?	No
	Obstruction Type			Storm Grate/Utility Type	
		N/A			N/A
			Yes	Surface Condition? (G/P)	Good

**Remove & Replace Entire Ramp.
Remove & Replace Gutter.**
