Access Compliance Report

Public Rights-of-Way

(Curb Ramps)

Intersection ID: 19683	Main Street: CONGRESS_ST	Cross Street: CARNEGIE_BV	Location: SE
ADA ID: BFD1F079A32B	Ramp Type: PerpDiag	Initial Pass/Fail: Fail	Overall Compliance: No
Severity Score: 12.5			
Codes/Mitigation Info/Possible Solution		Field Measurements/Component Compliance

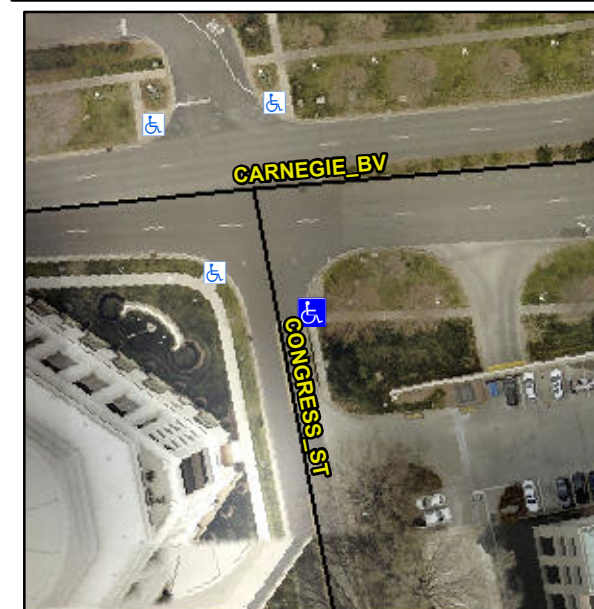
Compliance	Description	Data	Compliance	Description	Data
N/A	Ramp Length (in)	102.0	Yes	Ramp Slope (%)	6.1
Yes	Ramp Width (in)	48.0	No	Ramp XSlope (%)	5.3
N/A	Flare Type LT	N/A	N/A	Flare Type RT	N/A
N/A	Flare Slope LT (%)	N/A	N/A	Flare Slope RT (%)	N/A
N/A	Flare Traversable LT?	N/A	N/A	Flare Traversable RT?	N/A
N/A	Landing Length (in)	N/A	N/A	DWS Provided?	N/A
N/A	Landing Width (in)	N/A	N/A	DWS Contrast?	N/A
N/A	Landing Slope (%)	N/A	N/A	DWS Length (in)	N/A
N/A	Landing X Slope (%)	N/A	N/A	DWS Full Width?	N/A
N/A	Landing Curb? (Y/N)	N/A	N/A	DWS Offset (in)	N/A
N/A	Shared Landing?	N/A			
N/A	Gutter Ponding?	N/A	N/A	Gutter Slope (%)	N/A
N/A	Gutter Lip Ht (in)	N/A	N/A	Gutter X Slope (%)	N/A
N/A	Painted X Walk1?	No	N/A	Painted X Walk2?	No
	X Walk 1 Direction	To N		X Walk 2 Direction	To NW
N/A	X Walk 1 Width (in)	N/A	N/A	X Walk 2 Width (in)	N/A
	X Walk 1 Slope (%)	3.5		X Walk 2 Slope (%)	2.4
	X Walk 1 X Slope (%)	3.9		X Walk 2 X Slope (%)	5.3

N/A	Ramp inside XWalk1?	N/A	N/A	Ramp inside XWalk2?	N/A
	Road Slope (%)	5.7	N/A	Clear Space?	N/A
	Road X Slope (%)	2.5	N/A	Clear Space to XWalk (in)	N/A
N/A	Any Obstructions?	N/A	N/A	Storm Grate/Utility Hazard?	N/A
	Obstruction Type			Storm Grate/Utility Type	
		N/A			N/A
		Yes		Surface Condition? (G/P)	Good

Possible Solutions:

Remove & Replace Curb Ramp With Two New Directional Ramps or Equivalent.

R304.5.3
