Access Compliance Report

Public Rights-of-Way

(Curb Ramps)

Intersection ID: 45862	Main Street: JAMISON_LN	Cross Street: HENDERSON_OAKS_DR	Location: NE
ADA ID: BFDA6DB8EC0	Ramp Type: PerpDiag	Initial Pass/Fail: Fail	Overall Compliance: No
Severity Score: 33.75			
Codes/Mitigation Info/Possible Solution		Field Measurements/Component Compliance

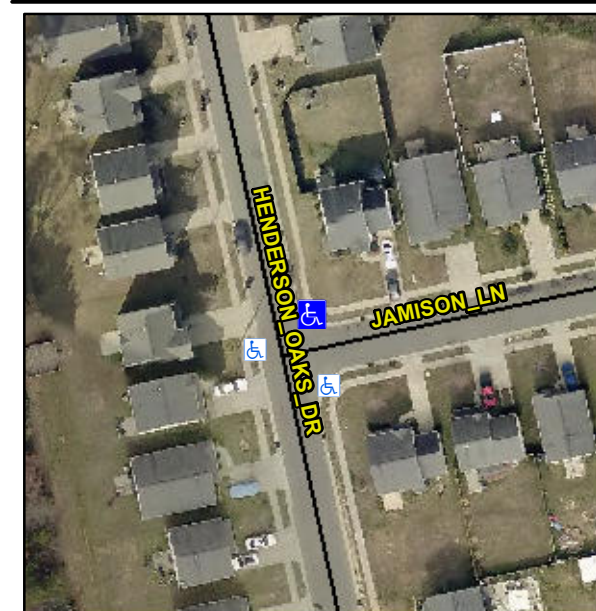
Compliance	Description	Data	Compliance	Description	Data
N/A	Ramp Length (in)	47.0	No	Ramp Slope (%)	12.8
No	Ramp Width (in)	36.0	Yes	Ramp XSlope (%)	1.6
N/A	Flare Type LT	N/A	N/A	Flare Type RT	N/A
N/A	Flare Slope LT (%)	N/A	N/A	Flare Slope RT (%)	N/A
N/A	Flare Traversable LT?	N/A	N/A	Flare Traversable RT?	N/A
N/A	Landing Length (in)	N/A	N/A	DWS Provided?	N/A
N/A	Landing Width (in)	N/A	N/A	DWS Contrast?	N/A
N/A	Landing Slope (%)	N/A	N/A	DWS Length (in)	N/A
N/A	Landing X Slope (%)	N/A	N/A	DWS Full Width?	N/A
N/A	Landing Curb? (Y/N)	N/A	N/A	DWS Offset (in)	N/A
N/A	Shared Landing?	N/A			
N/A	Gutter Ponding?	N/A	N/A	Gutter Slope (%)	N/A
N/A	Gutter Lip Ht (in)	N/A	N/A	Gutter X Slope (%)	N/A
N/A	Painted X Walk1?	No	N/A	Painted X Walk2?	No
	X Walk 1 Direction	To W		X Walk 2 Direction	To S
N/A	X Walk 1 Width (in)	N/A	N/A	X Walk 2 Width (in)	N/A
	X Walk 1 Slope (%)	1.9		X Walk 2 Slope (%)	4.4
	X Walk 1 X Slope (%)	1.6		X Walk 2 X Slope (%)	1.4

N/A	Ramp inside XWalk1?	N/A	N/A	Ramp inside XWalk2?	N/A
	Road Slope (%)	2.1	N/A	Clear Space?	N/A
	Road X Slope (%)	3.8	N/A	Clear Space to XWalk (in)	N/A
N/A	Any Obstructions?	N/A	N/A	Storm Grate/Utility Hazard?	N/A
	Obstruction Type			Storm Grate/Utility Type	
		N/A			N/A
			Yes	Surface Condition? (G/P)	Good

Remove & Replace Curb Ramp With Two New Directional Ramps or Equivalent.
