# Access Compliance Report

## Public Rights-of-Way

### (Curb Ramps)

Intersection ID: 11926	Main Street: WILKINSON_BV	Cross Street: BOYER_ST	Location: SE
ADA ID: BFE30364BC67	Ramp Type: Perp	Initial Pass/Fail: Fail	Overall Compliance: No
Codes/Mitigation Info/Possible Solution			Severity Score: 10
			Field Measurements/Component Compliance

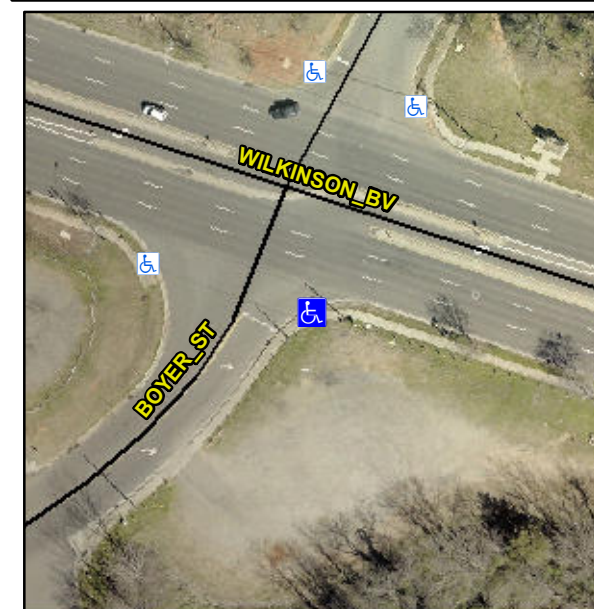
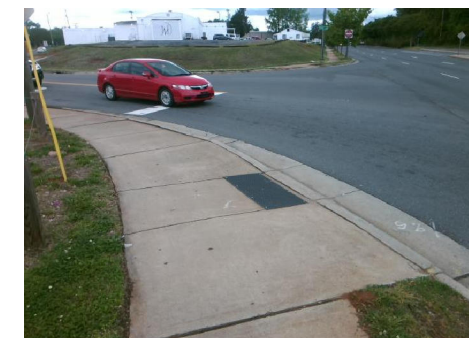
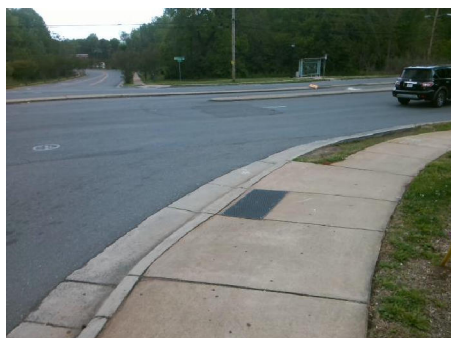
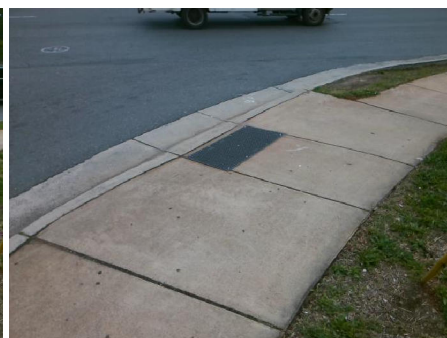
**R304.5.1, R304.5.3**

Compliance	Description	Data	Compliance	Description	Data
N/A	Ramp Length (in)	73.0	Yes	Ramp Slope (%)	8.0
No	Ramp Width (in)	44.0	No	Ramp XSlope (%)	3.2
N/A	Flare Type LT	N/A	N/A	Flare Type RT	N/A
N/A	Flare Slope LT (%)	N/A	N/A	Flare Slope RT (%)	N/A
N/A	Flare Traversable LT?	N/A	N/A	Flare Traversable RT?	N/A
N/A	Landing Length (in)	N/A	N/A	DWS Provided?	N/A
N/A	Landing Width (in)	N/A	N/A	DWS Contrast?	N/A
N/A	Landing Slope (%)	N/A	N/A	DWS Length (in)	N/A
N/A	Landing X Slope (%)	N/A	N/A	DWS Full Width?	N/A
N/A	Landing Curb? (Y/N)	N/A	N/A	DWS Offset (in)	N/A
N/A	Shared Landing?	N/A			
N/A	Gutter Ponding?	N/A	N/A	Gutter Slope (%)	N/A
N/A	Gutter Lip Ht (in)	N/A	N/A	Gutter X Slope (%)	N/A
N/A	Painted X Walk1?	No	N/A	Painted X Walk2?	N/A
	X Walk 1 Direction	To NW		X Walk 2 Direction	N/A
N/A	X Walk 1 Width (in)	N/A	N/A	X Walk 2 Width (in)	N/A
	X Walk 1 Slope (%)	1.0		X Walk 2 Slope (%)	N/A
	X Walk 1 X Slope (%)	2.8		X Walk 2 X Slope (%)	N/A

N/A	Ramp inside XWalk1?	N/A	N/A	Ramp inside XWalk2?	N/A
	Road Slope (%)	N/A	N/A	Clear Space?	N/A
	Road X Slope (%)	N/A	N/A	Clear Space to XWalk (in)	N/A
N/A	Any Obstructions?	N/A	N/A	Storm Grate/Utility Hazard?	N/A
	Obstruction Type			Storm Grate/Utility Type	
		N/A			N/A
			Yes	Surface Condition? (G/P)	Good

**Remove & Replace Entire Ramp.**

Total Cost: \$ 1850.00
