Access Compliance Report

Public Rights-of-Way

(Curb Ramps)

| Intersection ID: 20759 | Main Street: COLONY_CROSSING_DR | Cross Street: COLONY_RD | Location: NW |

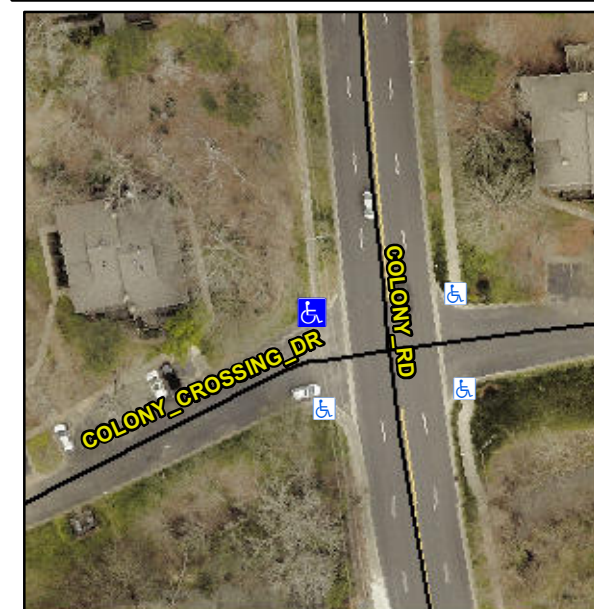
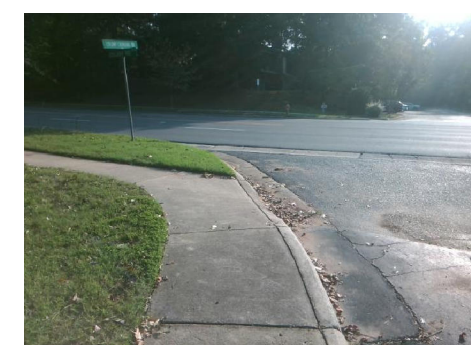
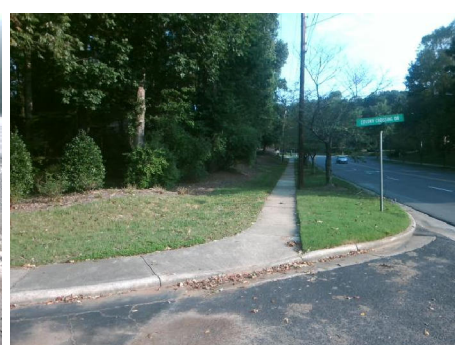
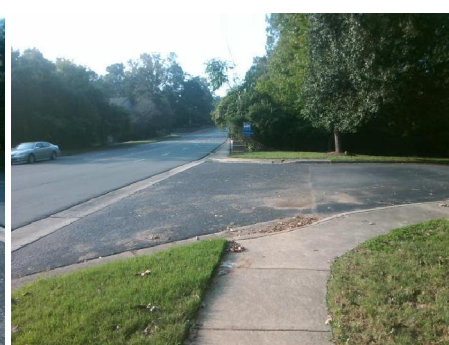
| ADA ID: BFF46FA9C1DF | Ramp Type: PerpDiag | Initial Pass/Fail: Fail | Overall Compliance: No |
| Severity Score: 22.5 | | | |

Not Found, R304.5.1, R304.2.2, R304.5.3

| Compliance | Description | Data | Compliance | Description | Data |
|---|---|---|---|---|---|
| N/A | Ramp Length (in) | 58.0 | No | Ramp Slope (%) | 10.4 |
| No | Ramp Width (in) | 36.0 | No | Ramp XSlope (%) | 2.2 |

Remove & Replace Curb Ramp With Two New Directional Ramps or Equivalent.
