Access Compliance Report

Public Rights-of-Way

(Curb Ramps)

Intersection ID: N/A	Main Street: SAM_NEELY_RD	Cross Street: STEELE_CREEK_RD	Location: SW
ADA ID: BFF6A83CDE6A	Ramp Type: Perp	Initial Pass/Fail: Fail	Overall Compliance: No
Severity Score: 21.25			
Codes/Mitigation Info/Possible Solution		Field Measurements/Component Compliance

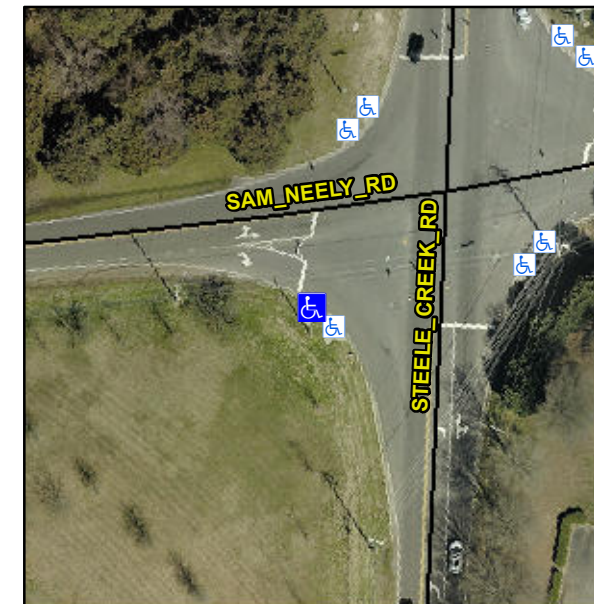
Compliance	Description	Data	Compliance	Description	Data
N/A	Ramp Length (in)	62.0	No	Ramp Slope (%)	11.8
No	Ramp Width (in)	46.0	Yes	Ramp XSlope (%)	1.0
N/A	Flare Type LT	N/A	N/A	Flare Type RT	N/A
N/A	Flare Slope LT (%)	N/A	N/A	Flare Slope RT (%)	N/A
N/A	Flare Traversable LT?	N/A	N/A	Flare Traversable RT?	N/A
N/A	Landing Length (in)	N/A	N/A	DWS Provided?	N/A
N/A	Landing Width (in)	N/A	N/A	DWS Contrast?	N/A
N/A	Landing Slope (%)	N/A	N/A	DWS Length (in)	N/A
N/A	Landing X Slope (%)	N/A	N/A	DWS Full Width?	N/A
N/A	Landing Curb? (Y/N)	N/A	N/A	DWS Offset (in)	N/A
N/A	Shared Landing?	N/A			
N/A	Gutter Ponding?	N/A	N/A	Gutter Slope (%)	N/A
N/A	Gutter Lip Ht (in)	N/A	N/A	Gutter X Slope (%)	N/A
N/A	Painted X Walk1?	No	N/A	Painted X Walk2?	N/A
	X Walk 1 Direction	To N		X Walk 2 Direction	N/A
N/A	X Walk 1 Width (in)	N/A	N/A	X Walk 2 Width (in)	N/A
	X Walk 1 Slope (%)	2.0		X Walk 2 Slope (%)	N/A
	X Walk 1 X Slope (%)	1.7		X Walk 2 X Slope (%)	N/A

N/A	Ramp inside XWalk1?	N/A	N/A	Ramp inside XWalk2?	N/A
	Road Slope (%)	N/A	N/A	Clear Space?	N/A
	Road X Slope (%)	N/A	N/A	Clear Space to XWalk (in)	N/A
N/A	Any Obstructions?	N/A	N/A	Storm Grate/Utility Hazard?	N/A
	Obstruction Type			Storm Grate/Utility Type	
		N/A			N/A
			Yes	Surface Condition? (G/P)	Good

Possible Solutions:

Remove & Replace Entire Ramp.

Not Found, R304.5.1, R304.2.2

Total Cost: \$ 1850.00
