Access Compliance Report

Public Rights-of-Way

(Curb Ramps)

Intersection ID: 48944	Main Street: LILLYSHIRE_PL	Cross Street: CALDWELL_RIDGE_PY	Location: W
ADA ID: C000F51E3B3B	Ramp Type: BlendTrans1	Initial Pass/Fail: Fail	Overall Compliance: No
Severity Score: 8.75			
Codes/Mitigation Info/Possible Solution		Field Measurements/Component Compliance

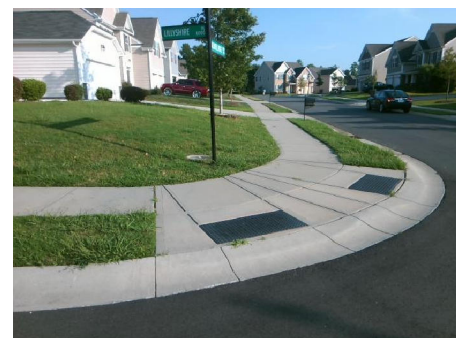
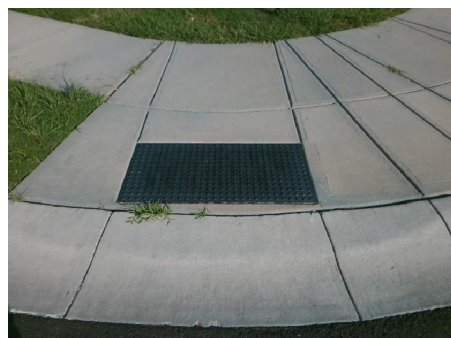
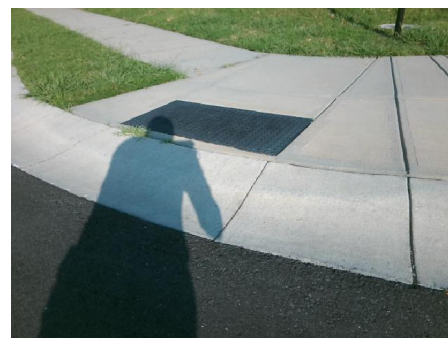
CURB GAP 1.0

Not Found, R304.5.1

Compliance	Description	Data	Compliance	Description	Data
N/A	Ramp Length (in)	46.5	Yes	BlendTrans Slope (%)	2.6
No	Ramp Width (in)	47.5	Yes	BlendTrans XSlope (%)	1.0
N/A	Flare Type LT	N/A	N/A	Flare Type RT	N/A
N/A	Flare Slope LT (%)	N/A	N/A	Flare Slope RT (%)	N/A
N/A	Flare Traversable LT?	N/A	N/A	Flare Traversable RT?	N/A
N/A	Landing Length (in)	N/A	N/A	DWS Provided?	N/A
N/A	Landing Width (in)	N/A	N/A	DWS Contrast?	N/A
N/A	Landing Slope (%)	N/A	N/A	DWS Length (in)	N/A
N/A	Landing X Slope (%)	N/A	N/A	DWS Full Width?	N/A
N/A	Landing Curb? (Y/N)	N/A	N/A	DWS Offset (in)	N/A
N/A	Shared Landing?	N/A			
N/A	Gutter Ponding?	N/A	N/A	Gutter Slope (%)	N/A
N/A	Gutter Lip Ht (in)	N/A	N/A	Gutter X Slope (%)	N/A
N/A	Painted X Walk1?	No	N/A	Painted X Walk2?	N/A
	X Walk 1 Direction	To S		X Walk 2 Direction	N/A
	X Walk 1 Width (in)	N/A		X Walk 2 Width (in)	N/A
	X Walk 1 Slope (%)	3.0		X Walk 2 Slope (%)	N/A
	X Walk 1 X Slope (%)	0.0		X Walk 2 X Slope (%)	N/A

N/A	Ramp inside XWalk1?	N/A	N/A	Ramp inside XWalk2?	N/A
	Road Slope (%)	0.0		Clear Space?	N/A
	Road X Slope (%)	3.0	N/A	Clear Space to XWalk (in)	N/A
N/A	Any Obstructions?	N/A	N/A	Storm Grate/Utility Hazard?	N/A
	Obstruction Type			Storm Grate/Utility Type	
		N/A			N/A
			Yes	Surface Condition? (G/P)	Good
			No	Curb Slope (%)	24.7

Possible Solutions:

Remove & Replace Curb Ramp With Two New Directional Ramps or Equivalent.
