Access Compliance Report

Public Rights-of-Way

(Curb Ramps)

Intersection ID: N/A	Main Street: UNIVERSITY_CITY_BV	Cross Street: N/A	Location: NW
ADA ID: C0044F7C5C4C	Ramp Type: Directional1	Initial Pass/Fail: Fail	Overall Compliance: No
		Severity Score: 1.25

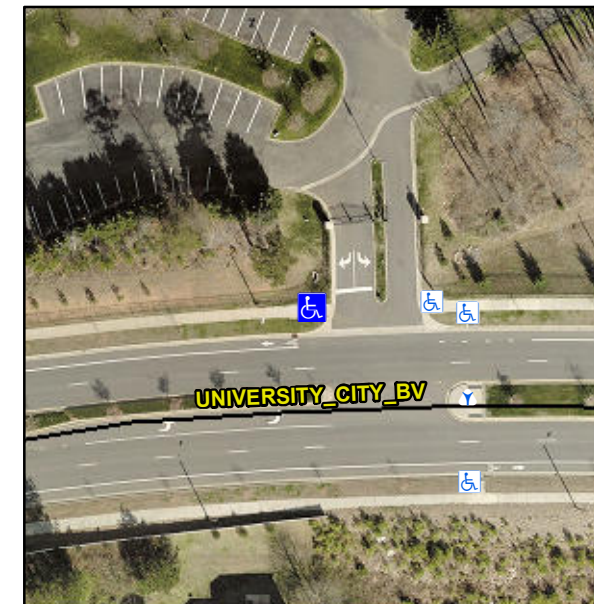
R304.5.3

Compliance	Description	Data	Compliance	Description	Data
N/A	Ramp Length (in)	223.0	N/A	Grade Break?	N/A
Yes	Ramp Width (in)	70.0	N/A	Grade Break Slope (%)	0.0
Yes	Ramp Slope (%)	7.8	N/A	Grade Break XSlope (%)	0.0
No	Ramp XSlope (%)	3.6			
N/A	Flare Type LT	N/A	N/A	Flare Type RT	N/A
N/A	Flare Slope LT (%)	N/A	N/A	Flare Slope RT (%)	0.0
N/A	Flare Traversable LT?	N/A	N/A	Flare Traversable RT?	N/A
N/A	Landing Length (in)	0.0	N/A	DWS Provided?	N/A
N/A	Landing Width (in)	0.0	N/A	DWS Contrast?	N/A
N/A	Landing Slope (%)	0.0	N/A	DWS Length (in)	N/A
N/A	Landing X Slope (%)	0.0	N/A	DWS Full Width?	N/A
N/A	Landing Curb? (Y/N)	N/A	N/A	DWS Offset LT (in)	N/A
N/A	Shared Landing?	N/A	N/A	DWS Offset RT (in)	N/A
N/A	Gutter Ponding?	0.0	N/A	Gutter Slope (%)	N/A
N/A	Gutter Lip Ht (in)	0.0	N/A	Gutter X Slope (%)	N/A
N/A	Painted X Walk1?	No		Road Slope (%)	2.6
	X Walk 1 Direction	To NE		Road X Slope (%)	3.3
	X Walk 1 Width (in)	N/A		Clear Space?	N/A

X Walk 1 Slope (%)	2.6	N/A	Clear Space to XWalk (in)	N/A
	X Walk 1 X Slope (%)	3.3	N/A	Storm Grate/Utility Hazard?	N/A
N/A	Ramp inside XWalk1?	N/A		Storm Grate/Utility Type	
N/A	Any Obstructions?	N/A			N/A
	Obstruction Type		Yes	Surface Condition? (G/P)	Good
			N/A	Curb Slope (%)	4.7

Remove & Replace Entire Ramp.
