Access Compliance Report

Public Rights-of-Way

(Curb Ramps)

Intersection ID: 25764	Main Street: MCMULLEN_CREEK_PY	Cross Street: PINEVILLE-MATTHEWS_RD	Location: NW
ADA ID: C011261FDD6F	Ramp Type: PerpDiag	Initial Pass/Fail: Fail	Overall Compliance: No
Severity Score: 22.5			
Codes/Mitigation Info/Possible Solution		Field Measurements/Component Compliance

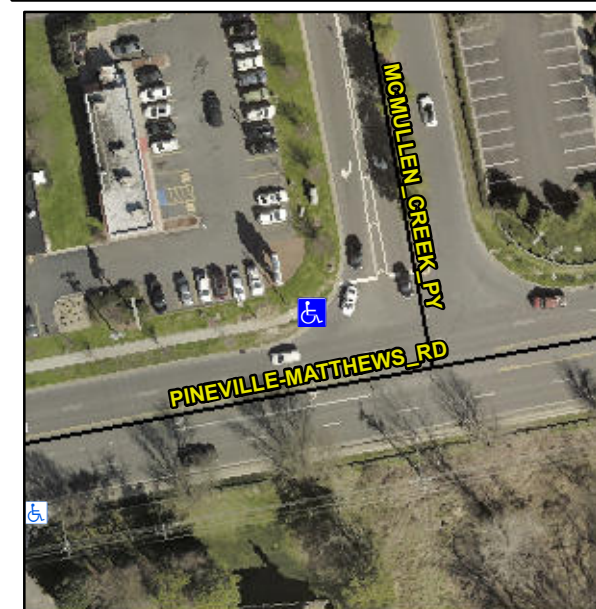
Not Found, R304.5.1, R304.2.2, R304.5.3

Compliance	Description	Data	Compliance	Description	Data
N/A	Ramp Length (in)	51.0	No	Ramp Slope (%)	8.4
No	Ramp Width (in)	44.0	No	Ramp XSlope (%)	2.8
N/A	Flare Type LT	N/A	N/A	Flare Type RT	N/A
N/A	Flare Slope LT (%)	N/A	N/A	Flare Slope RT (%)	N/A
N/A	Flare Traversable LT?	N/A	N/A	Flare Traversable RT?	N/A
N/A	Landing Length (in)	N/A	N/A	DWS Provided?	N/A
N/A	Landing Width (in)	N/A	N/A	DWS Contrast?	N/A
N/A	Landing Slope (%)	N/A	N/A	DWS Length (in)	N/A
N/A	Landing X Slope (%)	N/A	N/A	DWS Full Width?	N/A
N/A	Landing Curb? (Y/N)	N/A	N/A	DWS Offset (in)	N/A
N/A	Shared Landing?	N/A			
N/A	Gutter Ponding?	N/A	N/A	Gutter Slope (%)	N/A
N/A	Gutter Lip Ht (in)	2.5	N/A	Gutter X Slope (%)	N/A
N/A	Painted X Walk1?	No	N/A	Painted X Walk2?	No
	X Walk 1 Direction	To S		X Walk 2 Direction	To E
N/A	X Walk 1 Width (in)	N/A	N/A	X Walk 2 Width (in)	N/A
	X Walk 1 Slope (%)	5.8		X Walk 2 Slope (%)	3.4
	X Walk 1 X Slope (%)	5.1		X Walk 2 X Slope (%)	2.9

N/A	Ramp inside XWalk1?	N/A	N/A	Ramp inside XWalk2?	N/A
	Road Slope (%)	6.4	N/A	Clear Space?	N/A
	Road X Slope (%)	4.3	N/A	Clear Space to XWalk (in)	N/A
N/A	Any Obstructions?	N/A	N/A	Storm Grate/Utility Hazard?	N/A
	Obstruction Type			Storm Grate/Utility Type	
		N/A			N/A
			Yes	Surface Condition? (G/P)	Good

Remove & Replace Curb Ramp With Two New Directional Ramps or Equivalent.
