# Access Compliance Report

## Public Rights-of-Way

### (Curb Ramps)

Intersection ID: 14071	Main Street: CLEVELAND_AV	Cross Street: E_KINGSTON_AV	Location: E
ADA ID: C0157D764AC0	Ramp Type: Directional1	Initial Pass/Fail: Fail	Overall Compliance: No
		Severity Score: 1.25

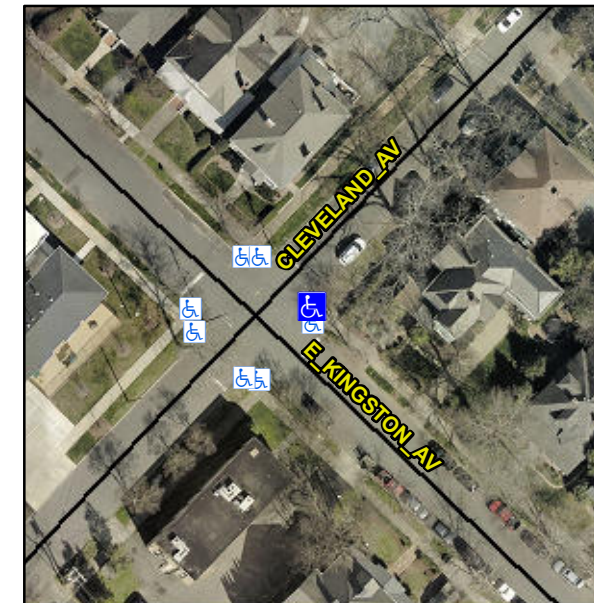
**NO CURB LINE**

**R304.5.3**

Compliance	Description	Data	Compliance	Description	Data
N/A	Ramp Length (in)	96.0	N/A	Grade Break?	N/A
Yes	Ramp Width (in)	72.0	N/A	Grade Break Slope (%)	0.0
Yes	Ramp Slope (%)	5.7	N/A	Grade Break XSlope (%)	0.0
No	Ramp XSlope (%)	2.6			
N/A	Flare Type LT	N/A	N/A	Flare Type RT	N/A
N/A	Flare Slope LT (%)	N/A	N/A	Flare Slope RT (%)	0.0
N/A	Flare Traversable LT?	N/A	N/A	Flare Traversable RT?	N/A
N/A	Landing Length (in)	0.0	N/A	DWS Provided?	N/A
N/A	Landing Width (in)	0.0	N/A	DWS Contrast?	N/A
N/A	Landing Slope (%)	0.0	N/A	DWS Length (in)	N/A
N/A	Landing X Slope (%)	0.0	N/A	DWS Full Width?	N/A
N/A	Landing Curb? (Y/N)	N/A	N/A	DWS Offset LT (in)	N/A
N/A	Shared Landing?	N/A	N/A	DWS Offset RT (in)	N/A
N/A	Gutter Ponding?	0.0	N/A	Gutter Slope (%)	N/A
N/A	Gutter Lip Ht (in)	0.0	N/A	Gutter X Slope (%)	N/A
N/A	Painted X Walk1?	No		Road Slope (%)	4.1
	X Walk 1 Direction	To NW		Road X Slope (%)	0.6
	X Walk 1 Width (in)	N/A		Clear Space?	N/A

X Walk 1 Slope (%)	4.1	N/A	Clear Space to XWalk (in)	N/A
	X Walk 1 X Slope (%)	0.6	N/A	Storm Grate/Utility Hazard?	N/A
N/A	Ramp inside XWalk1?	N/A		Storm Grate/Utility Type	
N/A	Any Obstructions?	N/A			N/A
	Obstruction Type		Yes	Surface Condition? (G/P)	Good
			N/A	Curb Slope (%)	4.9

**Remove & Replace Entire Ramp.**

\$ 1600.00
