# Access Compliance Report

## Public Rights-of-Way

### (Curb Ramps)

| Intersection ID: 19900 | Main Street: KEELING_PL | Cross Street: NETHERWOOD_DR | Location: SW |

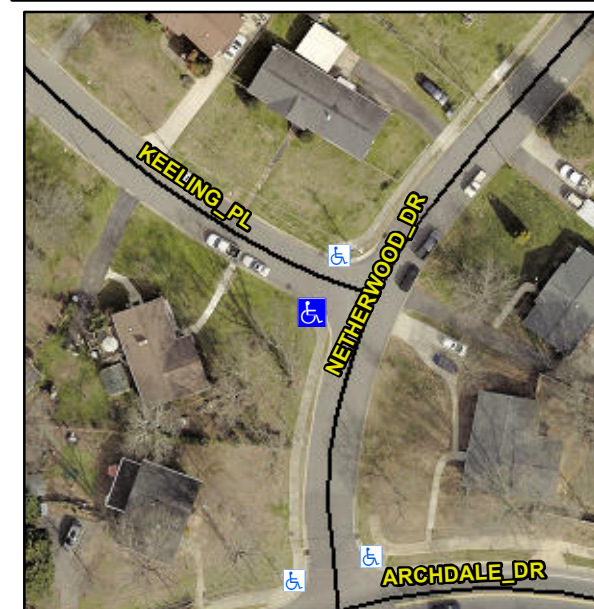
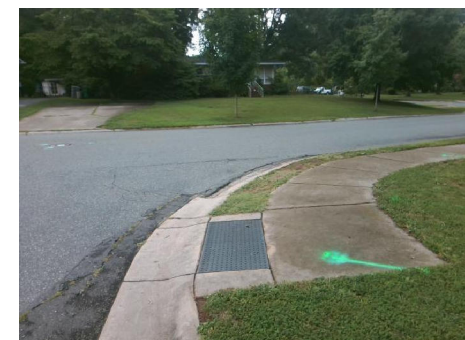
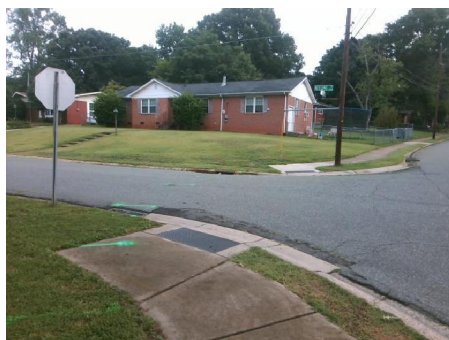
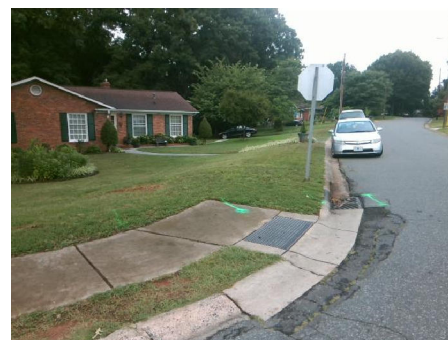
| ADA ID: C01D13D558DA | Ramp Type: BlendTrans2 | Initial Pass/Fail: Fail | Overall Compliance: No |
| Severity Score: 1.25 | | | |

**Not Found, R304.5.3**

| Compliance | Description | Data | Compliance | Description | Data |
|---|---|---|---|---|---|
| Yes | Ramp Width (in) | 48.0 | No | BlendTrans XSlope (%) | 2.3 |
| | | | No | Curb Slope (%) | 20.8 |

**Remove & Replace Curb Ramp With Two New Directional Ramps or Equivalent.**
