Access Compliance Report

Public Rights-of-Way

(Curb Ramps)

Intersection ID: 47929	Main Street: MOORES_CHAPEL_RD	Cross Street: KENDALL_DR	Location:	N/A
ADA ID: C021798086B2	Ramp Type: Perp	Initial Pass/Fail: Fail	Overall Compliance: No	Severity Score: 1.25
Codes/Mitigation Info/Possible Solution		Field Measurements/Component Compliance

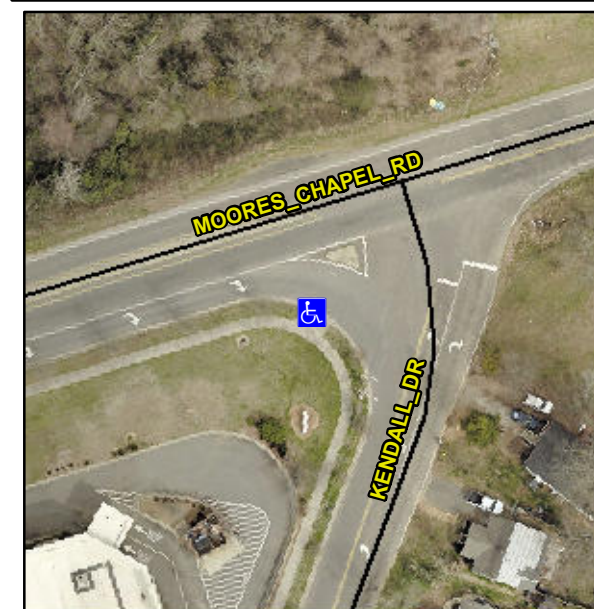
Not Found, R304.5.3

Compliance	Description	Data	Compliance	Description	Data
N/A	Ramp Length (in)	97.5	Yes	Ramp Slope (%)	6.3
Yes	Ramp Width (in)	55.0	No	Ramp XSlope (%)	2.3
N/A	Flare Type LT	N/A	N/A	Flare Type RT	N/A
N/A	Flare Slope LT (%)	N/A	N/A	Flare Slope RT (%)	N/A
N/A	Flare Traversable LT?	N/A	N/A	Flare Traversable RT?	N/A
N/A	Landing Length (in)	N/A	N/A	DWS Provided?	N/A
N/A	Landing Width (in)	N/A	N/A	DWS Contrast?	N/A
N/A	Landing Slope (%)	N/A	N/A	DWS Length (in)	N/A
N/A	Landing X Slope (%)	N/A	N/A	DWS Full Width?	N/A
N/A	Landing Curb? (Y/N)	N/A	N/A	DWS Offset (in)	N/A
N/A	Shared Landing?	N/A			
N/A	Gutter Ponding?	N/A	N/A	Gutter Slope (%)	N/A
N/A	Gutter Lip Ht (in)	N/A	N/A	Gutter X Slope (%)	N/A
N/A	Painted X Walk1?	No	N/A	Painted X Walk2?	N/A
	X Walk 1 Direction	To E		X Walk 2 Direction	N/A
N/A	X Walk 1 Width (in)	N/A	N/A	X Walk 2 Width (in)	N/A
	X Walk 1 Slope (%)	5.5		X Walk 2 Slope (%)	N/A
	X Walk 1 X Slope (%)	2.4		X Walk 2 X Slope (%)	N/A

N/A	Ramp inside XWalk1?	N/A	N/A	Ramp inside XWalk2?	N/A
	Road Slope (%)	2.4	N/A	Clear Space?	N/A
	Road X Slope (%)	5.5	N/A	Clear Space to XWalk (in)	N/A
N/A	Any Obstructions?	N/A	N/A	Storm Grate/Utility Hazard?	N/A
	Obstruction Type			Storm Grate/Utility Type	
		N/A			N/A
			Yes	Surface Condition? (G/P)	Good

Remove & Replace Entire Ramp.

Total Cost: \$ 1850.00
