Access Compliance Report

Public Rights-of-Way

(Curb Ramps)

Intersection ID: 13763	Main Street: CENTRAL_AV	Cross Street: EASTWAY_DR	Location: SE
ADA ID: C0280C3354D4	Ramp Type: Perp	Initial Pass/Fail: Fail	Overall Compliance: No
Severity Score: 22.5			
Codes/Mitigation Info/Possible Solution		Field Measurements/Component Compliance

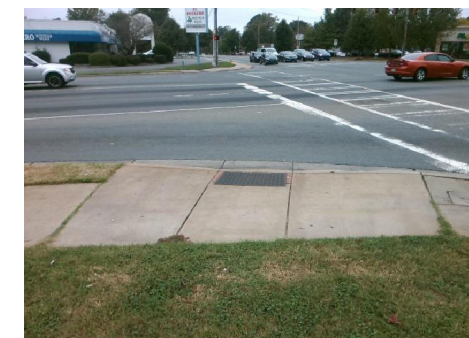
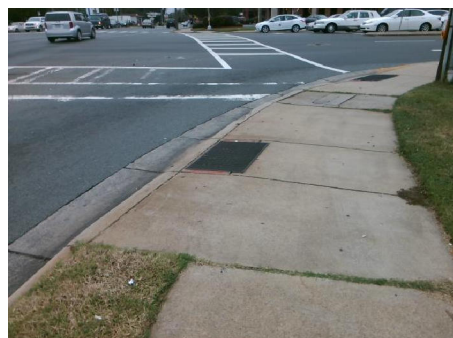
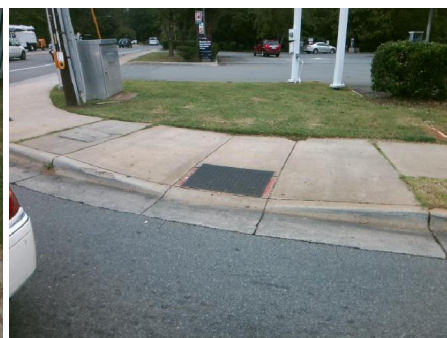
Not Found, R304.5.1, R304.2.2, R304.5.3

Compliance	Description	Data	Compliance	Description	Data
N/A	Ramp Length (in)	42.0	No	Ramp Slope (%)	8.4
No	Ramp Width (in)	45.0	No	Ramp XSlope (%)	2.4
N/A	Flare Type LT	N/A	N/A	Flare Type RT	N/A
N/A	Flare Slope LT (%)	N/A	N/A	Flare Slope RT (%)	N/A
N/A	Flare Traversable LT?	N/A	N/A	Flare Traversable RT?	N/A
N/A	Landing Length (in)	N/A	N/A	DWS Provided?	N/A
N/A	Landing Width (in)	N/A	N/A	DWS Contrast?	N/A
N/A	Landing Slope (%)	N/A	N/A	DWS Length (in)	N/A
N/A	Landing X Slope (%)	N/A	N/A	DWS Full Width?	N/A
N/A	Landing Curb? (Y/N)	N/A	N/A	DWS Offset (in)	N/A
N/A	Shared Landing?	N/A			
N/A	Gutter Ponding?	N/A	N/A	Gutter Slope (%)	N/A
N/A	Gutter Lip Ht (in)	N/A	N/A	Gutter X Slope (%)	N/A
N/A	Painted X Walk1?	No	N/A	Painted X Walk2?	N/A
	X Walk 1 Direction	To W		X Walk 2 Direction	N/A
N/A	X Walk 1 Width (in)	N/A	N/A	X Walk 2 Width (in)	N/A
	X Walk 1 Slope (%)	1.4		X Walk 2 Slope (%)	N/A
	X Walk 1 X Slope (%)	2.1		X Walk 2 X Slope (%)	N/A

N/A	Ramp inside XWalk1?	N/A	N/A	Ramp inside XWalk2?	N/A
	Road Slope (%)	N/A	N/A	Clear Space?	N/A
	Road X Slope (%)	N/A	N/A	Clear Space to XWalk (in)	N/A
N/A	Any Obstructions?	N/A	N/A	Storm Grate/Utility Hazard?	N/A
	Obstruction Type			Storm Grate/Utility Type	
		N/A			N/A
			Yes	Surface Condition? (G/P)	Good

Remove & Replace Entire Ramp.
