Access Compliance Report Public Rights-of-Way (Curb Ramps)

Intersection ID: 27072 Main Street: LUCERN_CT Cross Street: PIPER_GLEN_DR Location: N

ADA ID: C02ADB2AA0E3 Ramp Type: PerpDiag Initial Pass/Fail: Fail Overall Compliance: No Severity Score: 72.5

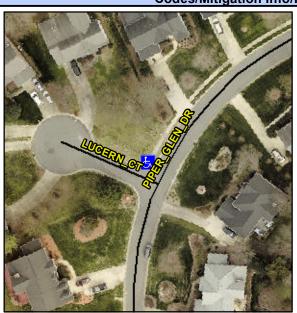
Field Measurements/Component Compliance					
Compliance Description		Data	Comp	oliance Description	Data
N/A	A Ramp Length (in)	98.0	No	Ramp Slope (%)	10.0
No	Ramp Width (in)	28.0	No	Ramp XSlope (%)	9.7
N/A	A Flare Type LT	N/A	N/A	Flare Type RT	N/A
N/A	A Flare Slope LT (%)	N/A	N/A	Flare Slope RT (%)	N/A
N/A	A Flare Traversable LT?	N/A	N/A	Flare Traversable RT?	N/A
N/A	A Landing Length (in)	N/A	N/A	DWS Provided?	N/A
N/A	A Landing Width (in)	N/A	N/A	DWS Contrast?	N/A
N/A	A Landing Slope (%)	N/A	N/A	DWS Length (in)	N/A
N/A	A Landing X Slope (%)	N/A	N/A	DWS Full Width?	N/A
N/A	A Landing Curb? (Y/N)	N/A	N/A	DWS Offset (in)	N/A
N/A	A Shared Landing?	N/A			
N/A	A Gutter Ponding?	N/A	N/A	Gutter Slope (%)	N/A
N/A	Gutter Lip Ht (in)	N/A	N/A	Gutter X Slope (%)	N/A
N/A	A Painted X Walk1?	No	N/A	Painted X Walk2?	No
	X Walk 1 Direction	To SW		X Walk 2 Direction	To SE
N/A	X Walk 1 Width (in)	N/A	N/A	X Walk 2 Width (in)	N/A

X Walk 1 Slope (%)	1.6		X Walk 2 Slope (%)	7.6
	X Walk 1 X Slope (%)	7.5		X Walk 2 X Slope (%)	1.3
N/A	A Ramp inside XWalk1?	N/A	N/A	Ramp inside XWalk2?	N/A
	Road Slope (%)	7.0	N/A	Clear Space?	N/A
	Road X Slope (%)	6.1	N/A	Clear Space to XWalk (in)	N/A
N/A	Any Obstructions?	N/A	N/A	Storm Grate/Utility Hazard?	N/A
	Obstruction Type			Storm Grate/Utility Type	
		N/A			N/A
			Yes	Surface Condition? (G/P)	Good
000

Remove & Replace Curb Ramp With
Two New Directional Ramps or
Equivalent.
