Access Compliance Report

Public Rights-of-Way

(Curb Ramps)

Intersection ID: 2855	Main Street: SWANSTON_DR	Cross Street: TORPHIN_CT	Location: NE
ADA ID: C0333BC2186A	Ramp Type: PerpDiag	Initial Pass/Fail: Fail	Overall Compliance: No
Severity Score: 12.5			
Codes/Mitigation Info/Possible Solution		Field Measurements/Component Compliance

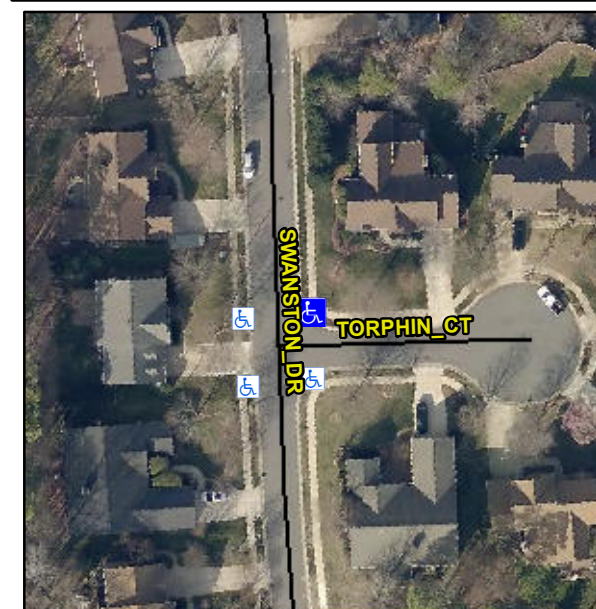
Not Found, R304.2.2

Compliance	Description	Data	Compliance	Description	Data
N/A	Ramp Length (in)	48.0	No	Ramp Slope (%)	9.9
Yes	Ramp Width (in)	60.0	Yes	Ramp XSlope (%)	0.1
N/A	Flare Type LT	N/A	N/A	Flare Type RT	N/A
N/A	Flare Slope LT (%)	N/A	N/A	Flare Slope RT (%)	N/A
N/A	Flare Traversable LT?	N/A	N/A	Flare Traversable RT?	N/A
N/A	Landing Length (in)	N/A	N/A	DWS Provided?	N/A
N/A	Landing Width (in)	N/A	N/A	DWS Contrast?	N/A
N/A	Landing Slope (%)	N/A	N/A	DWS Length (in)	N/A
N/A	Landing X Slope (%)	N/A	N/A	DWS Full Width?	N/A
N/A	Landing Curb? (Y/N)	N/A	N/A	DWS Offset (in)	N/A
N/A	Shared Landing?	N/A			
N/A	Gutter Ponding?	N/A	N/A	Gutter Slope (%)	N/A
N/A	Gutter Lip Ht (in)	N/A	N/A	Gutter X Slope (%)	N/A
N/A	Painted X Walk1?	No	N/A	Painted X Walk2?	No
	X Walk 1 Direction	To W		X Walk 2 Direction	To S
N/A	X Walk 1 Width (in)	N/A	N/A	X Walk 2 Width (in)	N/A
	X Walk 1 Slope (%)	4.6		X Walk 2 Slope (%)	1.9
	X Walk 1 X Slope (%)	1.6		X Walk 2 X Slope (%)	3.4

N/A	Ramp inside XWalk1?	N/A	N/A	Ramp inside XWalk2?	N/A
	Road Slope (%)	2.3	N/A	Clear Space?	N/A
	Road X Slope (%)	3.1	N/A	Clear Space to XWalk (in)	N/A
N/A	Any Obstructions?	N/A	N/A	Storm Grate/Utility Hazard?	N/A
	Obstruction Type			Storm Grate/Utility Type	
		N/A			N/A
		Yes		Surface Condition? (G/P)	Good

Remove & Replace Curb Ramp With Two New Directional Ramps or Equivalent.
