Access Compliance Report

Public Rights-of-Way (Curb Ramps)

Intersection ID: 23691	Main Street: BALTUSROL_LN	Cross Street: N/A	Location: SE
ADA ID: C038CE359937	Ramp Type: PerpDiag	Initial Pass/Fail: Fail	Overall Compliance: No
Severity Score: 8.75			
Codes/Mitigation Info/Possible Solution		Field Measurements/Component Compliance

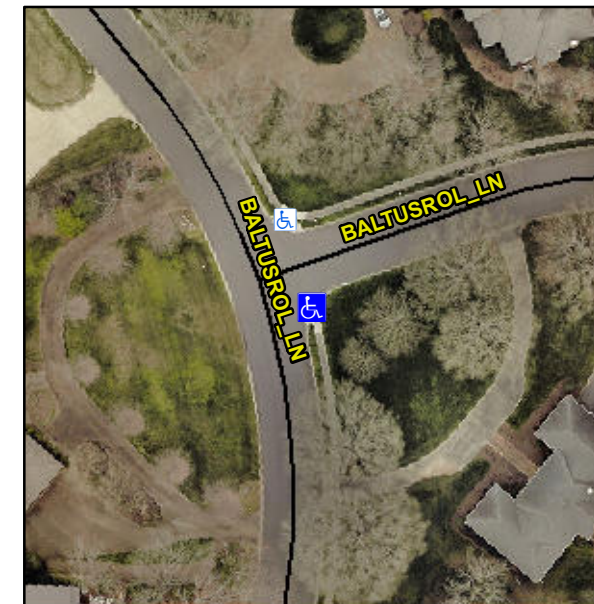
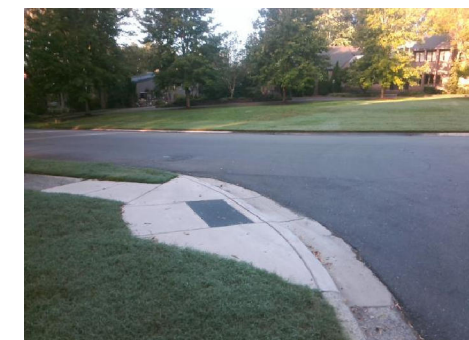
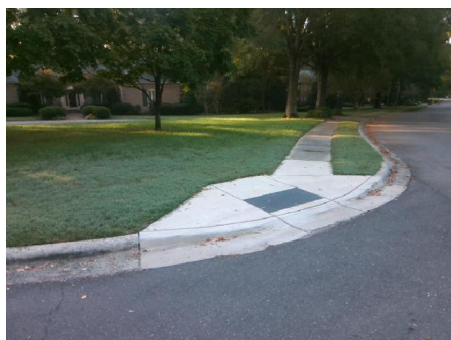
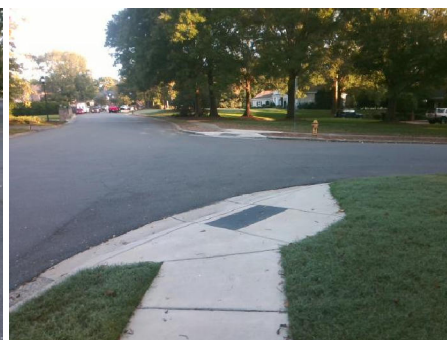
Not Found, R304.5.1

Compliance	Description	Data	Compliance	Description	Data
N/A	Ramp Length (in)	67.0	Yes	Ramp Slope (%)	5.9
No	Ramp Width (in)	47.0	Yes	Ramp XSlope (%)	1.3
N/A	Flare Type LT	N/A	N/A	Flare Type RT	N/A
N/A	Flare Slope LT (%)	N/A	N/A	Flare Slope RT (%)	N/A
N/A	Flare Traversable LT?	N/A	N/A	Flare Traversable RT?	N/A
N/A	Landing Length (in)	N/A	N/A	DWS Provided?	N/A
N/A	Landing Width (in)	N/A	N/A	DWS Contrast?	N/A
N/A	Landing Slope (%)	N/A	N/A	DWS Length (in)	N/A
N/A	Landing X Slope (%)	N/A	N/A	DWS Full Width?	N/A
N/A	Landing Curb? (Y/N)	N/A	N/A	DWS Offset (in)	N/A
N/A	Shared Landing?	N/A			
N/A	Gutter Ponding?	N/A	N/A	Gutter Slope (%)	N/A
N/A	Gutter Lip Ht (in)	N/A	N/A	Gutter X Slope (%)	N/A
N/A	Painted X Walk1?	No	N/A	Painted X Walk2?	No
	X Walk 1 Direction	To N		X Walk 2 Direction	To W
N/A	X Walk 1 Width (in)	N/A	N/A	X Walk 2 Width (in)	N/A
	X Walk 1 Slope (%)	4.0		X Walk 2 Slope (%)	2.1
	X Walk 1 X Slope (%)	2.2		X Walk 2 X Slope (%)	4.2

N/A	Ramp inside XWalk1?	N/A	N/A	Ramp inside XWalk2?	N/A
	Road Slope (%)	0.3	N/A	Clear Space?	N/A
	Road X Slope (%)	5.8	N/A	Clear Space to XWalk (in)	N/A
N/A	Any Obstructions?	N/A	N/A	Storm Grate/Utility Hazard?	N/A
	Obstruction Type			Storm Grate/Utility Type	
		N/A			N/A
			Yes	Surface Condition? (G/P)	Good

Remove & Replace Curb Ramp With Two New Directional Ramps or Equivalent.
