Access Compliance Report

Public Rights-of-Way

(Curb Ramps)

Intersection ID: 18202	Main Street: CLOVER_RD	Cross Street: S_SHARON_AMITY_RD	Location: S
ADA ID: C03AFDE7198C	Ramp Type: PerpDiag	Initial Pass/Fail: Fail	Overall Compliance: No
Severity Score: 37.5			
Codes/Mitigation Info/Possible Solution		Field Measurements/Component Compliance

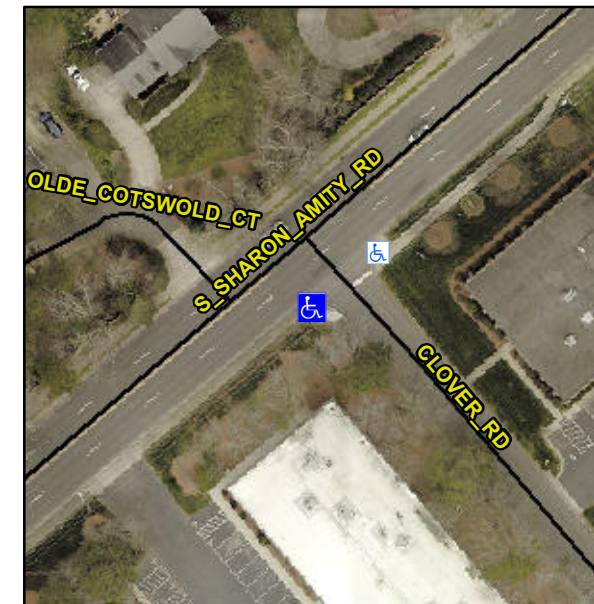
Not Found, R304.2.2, R304.5.3

Compliance	Description	Data	Compliance	Description	Data
N/A	Ramp Length (in)	96.0	No	Ramp Slope (%)	10.8
Yes	Ramp Width (in)	48.0	No	Ramp XSlope (%)	7.0
N/A	Flare Type LT	N/A	N/A	Flare Type RT	N/A
N/A	Flare Slope LT (%)	N/A	N/A	Flare Slope RT (%)	N/A
N/A	Flare Traversable LT?	N/A	N/A	Flare Traversable RT?	N/A
N/A	Landing Length (in)	N/A	N/A	DWS Provided?	N/A
N/A	Landing Width (in)	N/A	N/A	DWS Contrast?	N/A
N/A	Landing Slope (%)	N/A	N/A	DWS Length (in)	N/A
N/A	Landing X Slope (%)	N/A	N/A	DWS Full Width?	N/A
N/A	Landing Curb? (Y/N)	N/A	N/A	DWS Offset (in)	N/A
N/A	Shared Landing?	N/A			
N/A	Gutter Ponding?	N/A	N/A	Gutter Slope (%)	N/A
N/A	Gutter Lip Ht (in)	N/A	N/A	Gutter X Slope (%)	N/A
N/A	Painted X Walk1?	No	N/A	Painted X Walk2?	No
	X Walk 1 Direction	To NE		X Walk 2 Direction	To NW
N/A	X Walk 1 Width (in)	N/A	N/A	X Walk 2 Width (in)	N/A
	X Walk 1 Slope (%)	6.5		X Walk 2 Slope (%)	3.0
	X Walk 1 X Slope (%)	1.4		X Walk 2 X Slope (%)	2.9

N/A	Ramp inside XWalk1?	N/A	N/A	Ramp inside XWalk2?	N/A
	Road Slope (%)	6.1	N/A	Clear Space?	N/A
	Road X Slope (%)	5.8	N/A	Clear Space to XWalk (in)	N/A
N/A	Any Obstructions?	N/A	N/A	Storm Grate/Utility Hazard?	N/A
	Obstruction Type			Storm Grate/Utility Type	
		N/A			N/A
			Yes	Surface Condition? (G/P)	Good

Remove & Replace Curb Ramp With Two New Directional Ramps or Equivalent.
