Access Compliance Report

Public Rights-of-Way

(Curb Ramps)

Intersection ID: 22578	Main Street: MAGNOLIA_BRIDGE_RD	Cross Street: QUAIL_HOLLOW_RD	Location: NW
ADA ID: C04A613F40FB	Ramp Type: PerpDiag	Initial Pass/Fail: Fail	Overall Compliance: No
Severity Score: 22.5			
Codes/Mitigation Info/Possible Solution		Field Measurements/Component Compliance

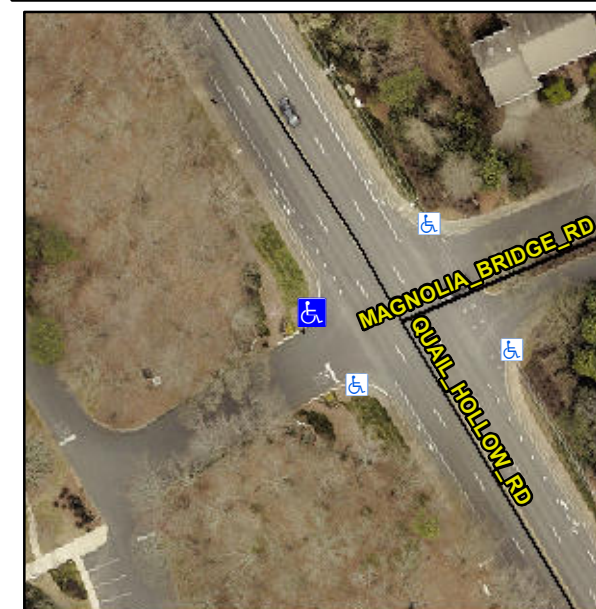
Not Found, R304.5.1, R304.2.2, R304.5.3

Compliance	Description	Data	Compliance	Description	Data
N/A	Ramp Length (in)	50.0	No	Ramp Slope (%)	10.2
No	Ramp Width (in)	39.0	No	Ramp XSlope (%)	3.1
N/A	Flare Type LT	N/A	N/A	Flare Type RT	N/A
N/A	Flare Slope LT (%)	N/A	N/A	Flare Slope RT (%)	N/A
N/A	Flare Traversable LT?	N/A	N/A	Flare Traversable RT?	N/A
N/A	Landing Length (in)	N/A	N/A	DWS Provided?	N/A
N/A	Landing Width (in)	N/A	N/A	DWS Contrast?	N/A
N/A	Landing Slope (%)	N/A	N/A	DWS Length (in)	N/A
N/A	Landing X Slope (%)	N/A	N/A	DWS Full Width?	N/A
N/A	Landing Curb? (Y/N)	N/A	N/A	DWS Offset (in)	N/A
N/A	Shared Landing?	N/A			
N/A	Gutter Ponding?	N/A	N/A	Gutter Slope (%)	N/A
N/A	Gutter Lip Ht (in)	N/A	N/A	Gutter X Slope (%)	N/A
N/A	Painted X Walk1?	No	N/A	Painted X Walk2?	No
	X Walk 1 Direction	To SE		X Walk 2 Direction	To NE
N/A	X Walk 1 Width (in)	N/A	N/A	X Walk 2 Width (in)	N/A
	X Walk 1 Slope (%)	5.2		X Walk 2 Slope (%)	1.8
	X Walk 1 X Slope (%)	0.7		X Walk 2 X Slope (%)	4.2

N/A	Ramp inside XWalk1?	N/A	N/A	Ramp inside XWalk2?	N/A
	Road Slope (%)	1.4	N/A	Clear Space?	N/A
	Road X Slope (%)	4.8	N/A	Clear Space to XWalk (in)	N/A
N/A	Any Obstructions?	N/A	N/A	Storm Grate/Utility Hazard?	N/A
	Obstruction Type			Storm Grate/Utility Type	
		N/A			N/A
		Yes		Surface Condition? (G/P)	Good

Possible Solutions:

Remove & Replace Curb Ramp With Two New Directional Ramps or Equivalent.

Total Cost: \$ 3200.00
