# Access Compliance Report

## Public Rights-of-Way

### (Curb Ramps)

| Intersection ID: 9123 | Main Street: ROZZELLES_FERRY_RD | Cross Street: CORONET_WY | Location: E |

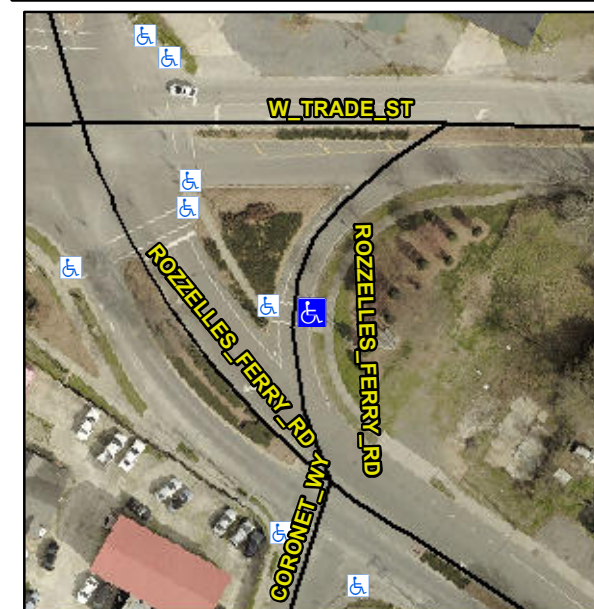
| ADA ID: C06606C79F83 | Ramp Type: Perp | Initial Pass/Fail: Fail | Overall Compliance: No |

**Not Found, R304.5.1, R304.5.3**

| Compliance | Description | Data | Compliance | Description | Data |
|---|---|---|---|---|---|
| N/A | Ramp Length (in) | 70.0 | Yes | Ramp Slope (%) | 5.7 |
| No | Ramp Width (in) | 47.0 | No | Ramp XSlope (%) | 3.7 |

Possible Solutions:

**Remove & Replace Entire Ramp.**

Total Cost: \$ 1850.00
