Access Compliance Report

Public Rights-of-Way

(Curb Ramps)

Intersection ID: 21458	Main Street: PROVIDENCE_RD	Cross Street: SARDIS_LN	Location: NE
ADA ID: C072933ABDEF	Ramp Type: PerpDiag	Initial Pass/Fail: Fail	Overall Compliance: No
		Severity Score: 22.5

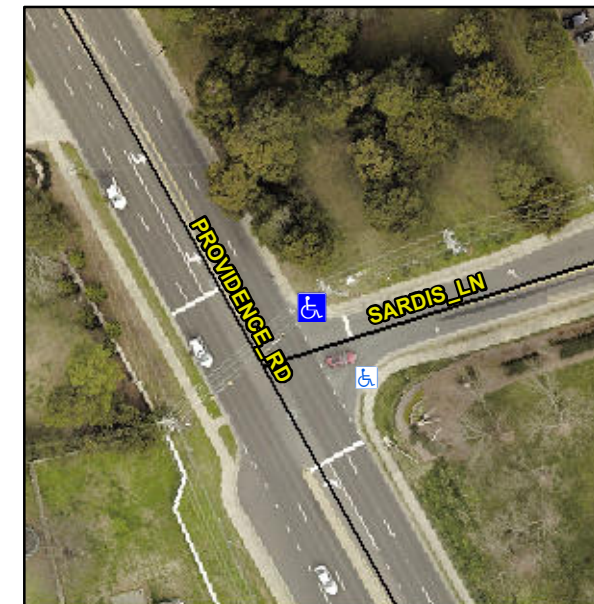
Not Found, R304.5.1, R304.2.2, R304.5.3

Compliance	Description	Data	Compliance	Description	Data
N/A	Ramp Length (in)	45.0	No	Ramp Slope (%)	9.2
No	Ramp Width (in)	43.0	No	Ramp XSlope (%)	3.1
N/A	Flare Type LT	N/A	N/A	Flare Type RT	N/A
N/A	Flare Slope LT (%)	N/A	N/A	Flare Slope RT (%)	N/A
N/A	Flare Traversable LT?	N/A	N/A	Flare Traversable RT?	N/A
N/A	Landing Length (in)	N/A	N/A	DWS Provided?	N/A
N/A	Landing Width (in)	N/A	N/A	DWS Contrast?	N/A
N/A	Landing Slope (%)	N/A	N/A	DWS Length (in)	N/A
N/A	Landing X Slope (%)	N/A	N/A	DWS Full Width?	N/A
N/A	Landing Curb? (Y/N)	N/A	N/A	DWS Offset (in)	N/A
N/A	Shared Landing?	N/A			
N/A	Gutter Ponding?	N/A	N/A	Gutter Slope (%)	N/A
N/A	Gutter Lip Ht (in)	N/A	N/A	Gutter X Slope (%)	N/A
N/A	Painted X Walk1?	No	N/A	Painted X Walk2?	No
	X Walk 1 Direction	To SW		X Walk 2 Direction	To SE
N/A	X Walk 1 Width (in)	N/A	N/A	X Walk 2 Width (in)	N/A
	X Walk 1 Slope (%)	0.9		X Walk 2 Slope (%)	0.4
	X Walk 1 X Slope (%)	0.5		X Walk 2 X Slope (%)	0.1

N/A	Ramp inside XWalk1?	N/A	N/A	Ramp inside XWalk2?	N/A
	Road Slope (%)	1.9	N/A	Clear Space?	N/A
	Road X Slope (%)	1.4	N/A	Clear Space to XWalk (in)	N/A
N/A	Any Obstructions?	N/A	N/A	Storm Grate/Utility Hazard?	N/A
	Obstruction Type			Storm Grate/Utility Type	
		N/A			N/A
			Yes	Surface Condition? (G/P)	Good

Possible Solutions:

Remove & Replace Curb Ramp With Two New Directional Ramps or Equivalent.
