# Access Compliance Report

## Public Rights-of-Way

### (Curb Ramps)

| Intersection ID: 11318 | Main Street: GRANDIN_RD | Cross Street: W_4TH_ST_EXT | Location: SW |

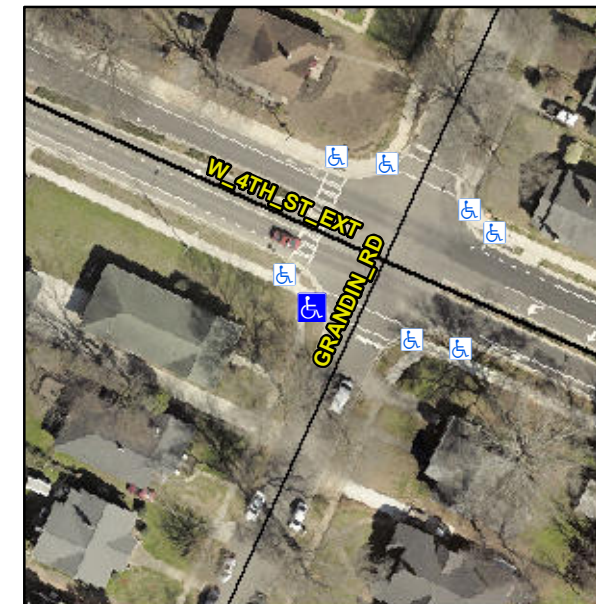
**Not Found, R304.2.1, R305.2**

| Compliance | Description | Data | Compliance | Description | Data |
|---|---|---|---|---|---|
| No | Landing Length (in) | 46.5 | Yes | DWS Provided? | Yes |
| N/A | Landing Curb? (Y/N) | No | No | DWS Offset (in) | 2.5 |

**Remove & Replace Entire Ramp.**
