# Access Compliance Report

## Public Rights-of-Way

### (Curb Ramps)

Intersection ID: 49507	Main Street: OSCEOLA_LN	Cross Street: ANKENY_CT	Location:	N
ADA ID: C078AC584698	Ramp Type: PerpDiag	Initial Pass/Fail: Fail	Overall Compliance: No	Severity Score: 46.25
Codes/Mitigation Info/Possible Solution		Field Measurements/Component Compliance

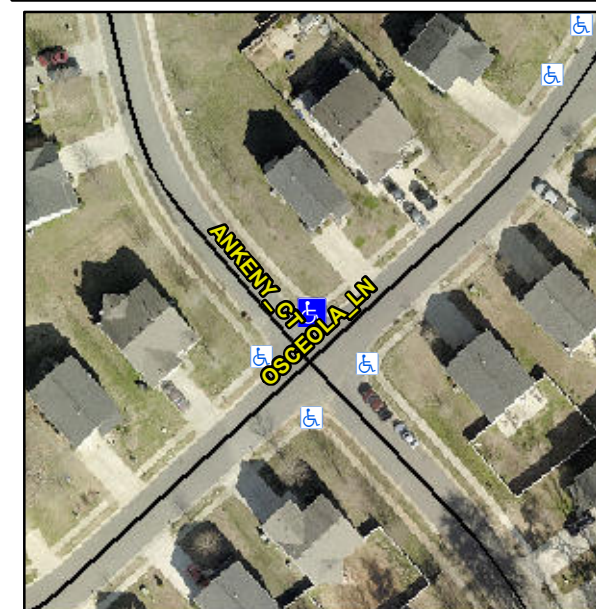
**Not Found, R304.5.1, R304.2.2, R304.5.3**

Compliance	Description	Data	Compliance	Description	Data
N/A	Ramp Length (in)	48.0	No	Ramp Slope (%)	17.0
No	Ramp Width (in)	44.0	No	Ramp XSlope (%)	6.8
N/A	Flare Type LT	N/A	N/A	Flare Type RT	N/A
N/A	Flare Slope LT (%)	N/A	N/A	Flare Slope RT (%)	N/A
N/A	Flare Traversable LT?	N/A	N/A	Flare Traversable RT?	N/A
N/A	Landing Length (in)	N/A	N/A	DWS Provided?	N/A
N/A	Landing Width (in)	N/A	N/A	DWS Contrast?	N/A
N/A	Landing Slope (%)	N/A	N/A	DWS Length (in)	N/A
N/A	Landing X Slope (%)	N/A	N/A	DWS Full Width?	N/A
N/A	Landing Curb? (Y/N)	N/A	N/A	DWS Offset (in)	N/A
N/A	Shared Landing?	N/A			
N/A	Gutter Ponding?	N/A	N/A	Gutter Slope (%)	N/A
N/A	Gutter Lip Ht (in)	N/A	N/A	Gutter X Slope (%)	N/A
N/A	Painted X Walk1?	No	N/A	Painted X Walk2?	No
	X Walk 1 Direction	To SW		X Walk 2 Direction	To SE
N/A	X Walk 1 Width (in)	N/A	N/A	X Walk 2 Width (in)	N/A
	X Walk 1 Slope (%)	7.6		X Walk 2 Slope (%)	6.5
	X Walk 1 X Slope (%)	0.8		X Walk 2 X Slope (%)	7.2

N/A	Ramp inside XWalk1?	N/A	N/A	Ramp inside XWalk2?	N/A
	Road Slope (%)	4.5	N/A	Clear Space?	N/A
	Road X Slope (%)	8.0	N/A	Clear Space to XWalk (in)	N/A
N/A	Any Obstructions?	N/A	N/A	Storm Grate/Utility Hazard?	N/A
	Obstruction Type			Storm Grate/Utility Type	
		N/A			N/A
			Yes	Surface Condition? (G/P)	Good

Possible Solutions:

**Remove & Replace Curb Ramp With Two New Directional Ramps or Equivalent.**
