Access Compliance Report

Public Rights-of-Way

(Curb Ramps)

Intersection ID: 47821	Main Street: VERDE_CT	Cross Street: ROYAL_FERN_LN	Location: NW
ADA ID: C08B140268DC	Ramp Type: Perp	Initial Pass/Fail: Fail	Overall Compliance: No
		Severity Score: 8.75	
Codes/Mitigation Info/Possible Solution		Field Measurements/Component Compliance

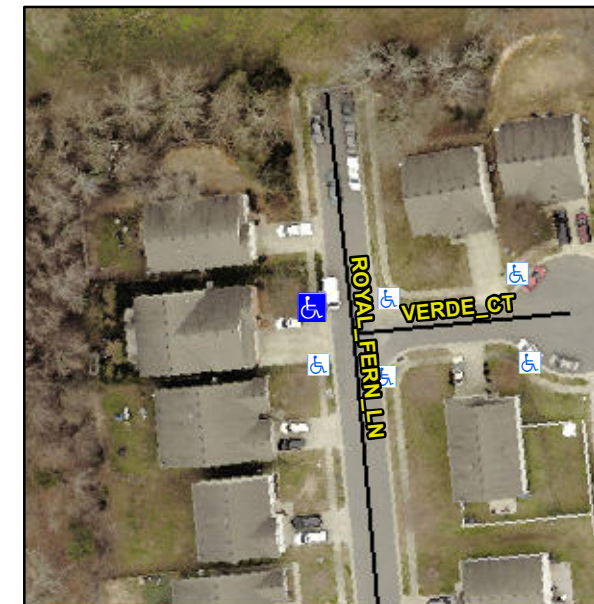
Not Found, R304.5.1

Compliance	Description	Data	Compliance	Description	Data
N/A	Ramp Length (in)	48.0	Yes	Ramp Slope (%)	6.3
No	Ramp Width (in)	47.5	Yes	Ramp XSlope (%)	1.5
N/A	Flare Type LT	N/A	N/A	Flare Type RT	N/A
N/A	Flare Slope LT (%)	N/A	N/A	Flare Slope RT (%)	N/A
N/A	Flare Traversable LT?	N/A	N/A	Flare Traversable RT?	N/A
N/A	Landing Length (in)	N/A	N/A	DWS Provided?	N/A
N/A	Landing Width (in)	N/A	N/A	DWS Contrast?	N/A
N/A	Landing Slope (%)	N/A	N/A	DWS Length (in)	N/A
N/A	Landing X Slope (%)	N/A	N/A	DWS Full Width?	N/A
N/A	Landing Curb? (Y/N)	N/A	N/A	DWS Offset (in)	N/A
N/A	Shared Landing?	N/A			
N/A	Gutter Ponding?	N/A	N/A	Gutter Slope (%)	N/A
N/A	Gutter Lip Ht (in)	N/A	N/A	Gutter X Slope (%)	N/A
N/A	Painted X Walk1?	No	N/A	Painted X Walk2?	N/A
	X Walk 1 Direction	To E		X Walk 2 Direction	N/A
N/A	X Walk 1 Width (in)	N/A	N/A	X Walk 2 Width (in)	N/A
	X Walk 1 Slope (%)	3.1		X Walk 2 Slope (%)	N/A
	X Walk 1 X Slope (%)	1.1		X Walk 2 X Slope (%)	N/A

N/A	Ramp inside XWalk1?	N/A	N/A	Ramp inside XWalk2?	N/A
	Road Slope (%)	N/A	N/A	Clear Space?	N/A
	Road X Slope (%)	N/A	N/A	Clear Space to XWalk (in)	N/A
N/A	Any Obstructions?	N/A	N/A	Storm Grate/Utility Hazard?	N/A
	Obstruction Type			Storm Grate/Utility Type	
		N/A			N/A
			Yes	Surface Condition? (G/P)	Good

Possible Solutions:

Remove & Replace Entire Ramp.
